WIRE ROPE

Magnetism in rope wires

by Dipl.-Ing. Roland Verreet

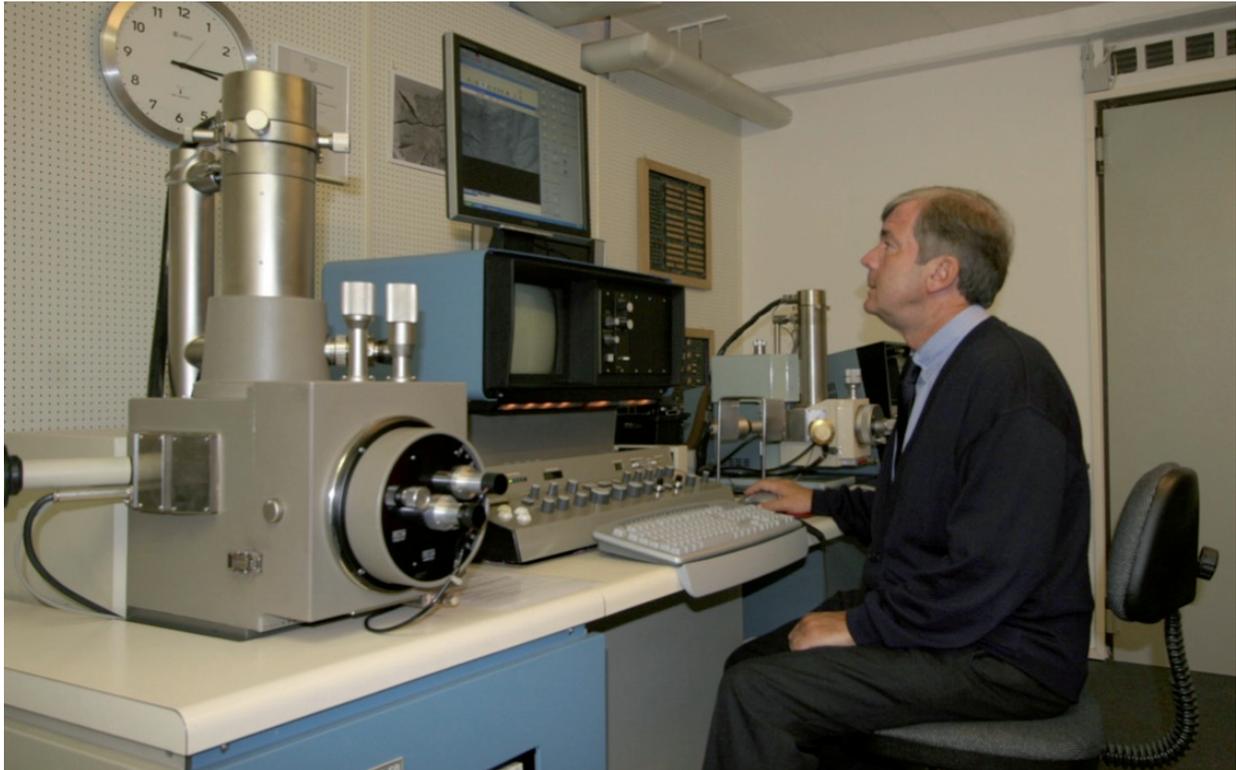
Fig. 1: A Scanning Electron Microscope (SEM)

When a wire sample is analysed in a scanning electron microscope (Fig. 1) it is put in a vacuum chamber (Fig. 2). After evacuating the chamber, a high voltage is applied between a heated cathode and the specimen which acts as an anode. Electrons are then emitted from the cathode and accelerated towards the specimen. A scintillator then detects the secondary electrons emitted from the specimen, and an image of the specimen surface can be created.

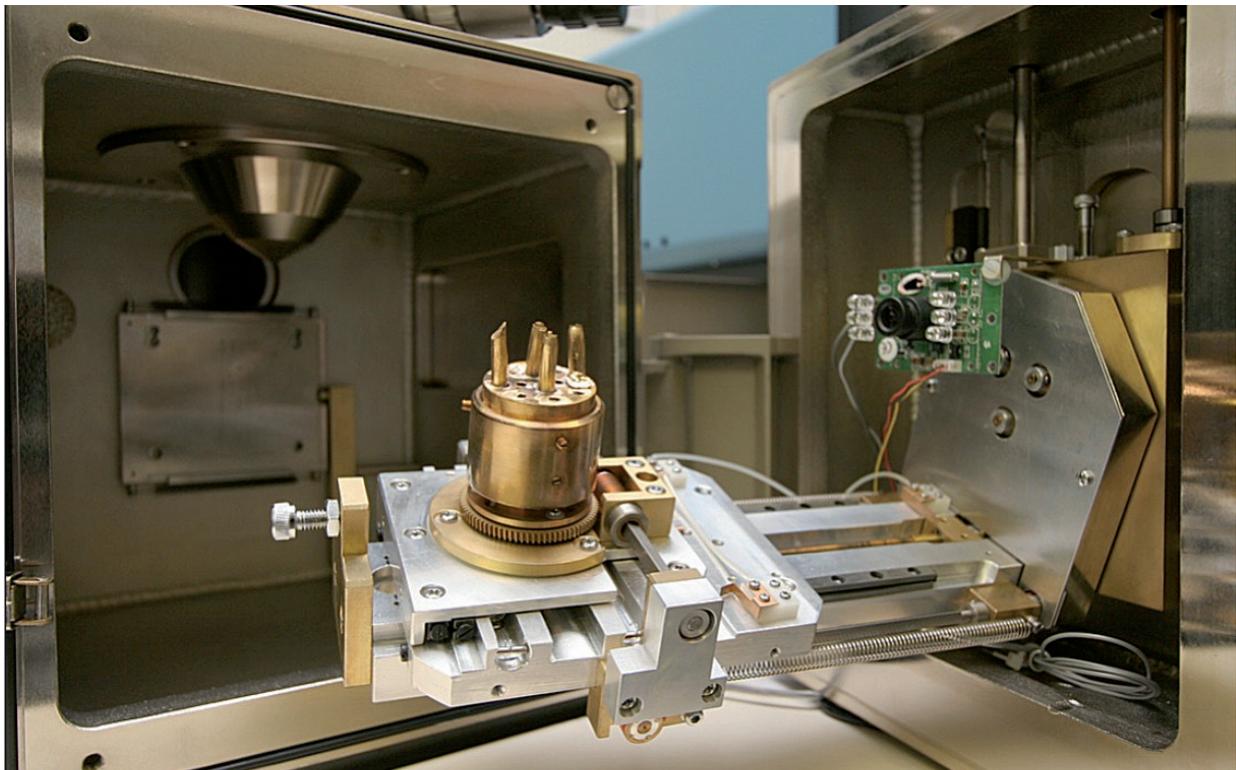
Fig. 2: Detail of the vacuum chamber of a scanning electron microscope. This chamber can be seen closed at the left hand side of Fig. 1.

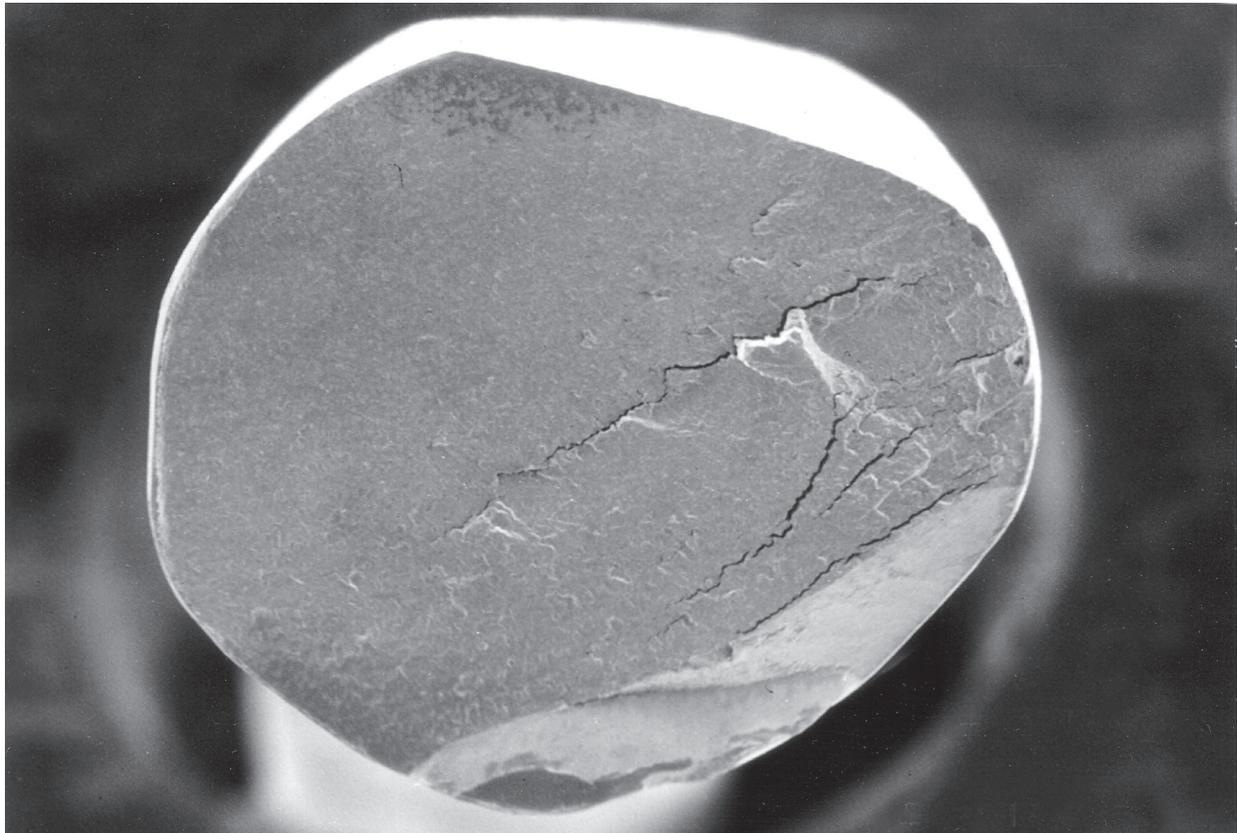
Fig. 3: Typical fracture surface of a wire which has failed owing to tension-tension fatigue

The author has been analysing rope wires in scanning electron microscopes since 1978 [1]. In many cases where a wire had to be demagnetised in order to stabilise the image created by the microscope, the wire break surface later revealed the typical structure of a wire that has fatigued in bending fatigue or tension-tension mode (Fig. 3).

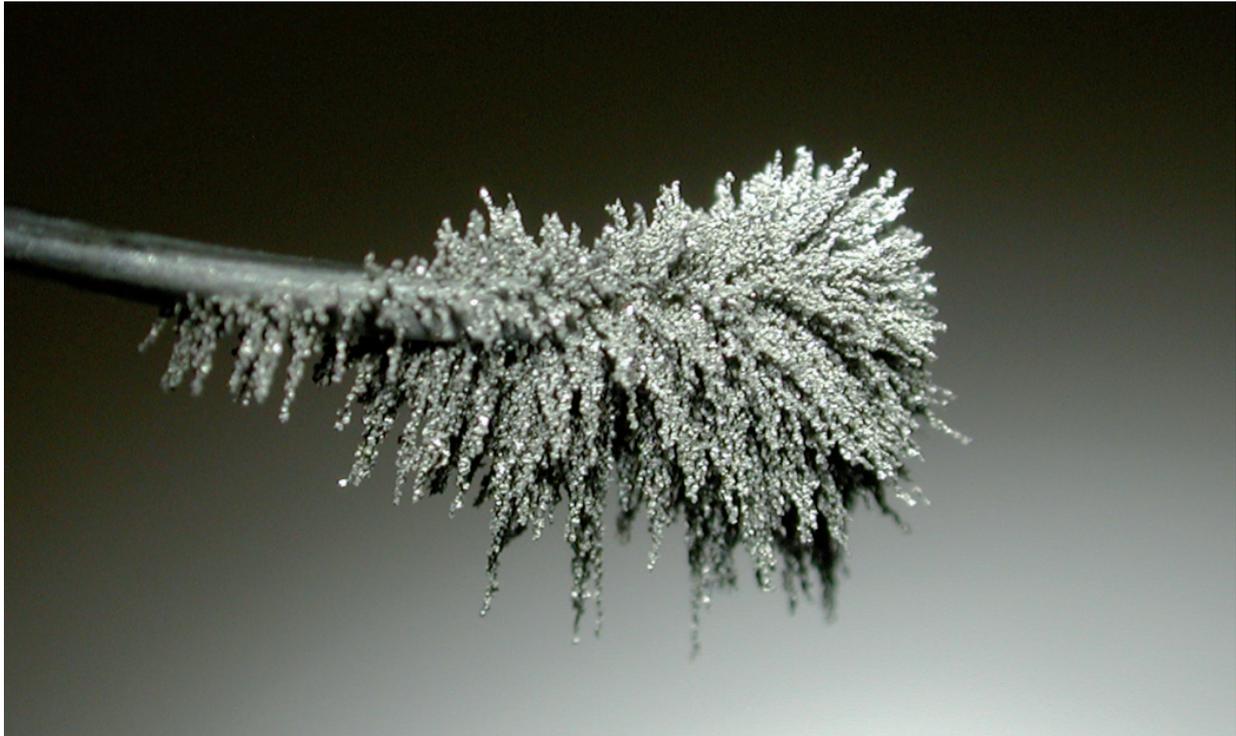
Fig. 4: The wire fracture end of wire which has failed due to tension-tension fatigue after dipping it into iron powder. The wire is highly magnetic.

The author has therefore subjected several steel wire ropes to both bending fatigue and tension-tension fatigue tests. It could be stated that tension-tension fatigue created a high degree of magnetism, and bending fatigue a lesser degree. This could simply be measured by using iron powder (iron filings) which was either attracted by the wire (Fig. 4).

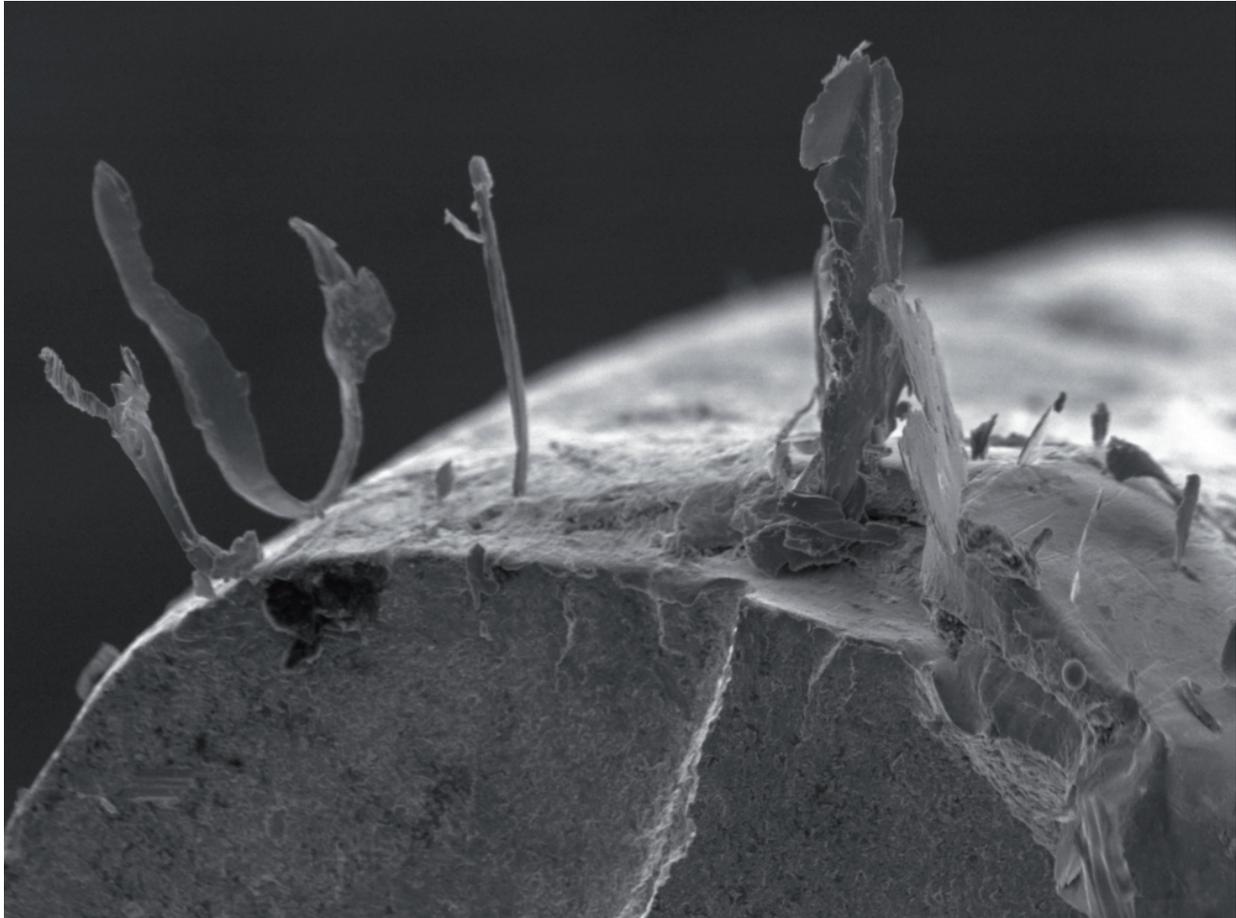
Fig. 5 shows a wire from the roller coaster in the original, non demagnetised condition. Because of the disturbance from the magnetic field of the wire the image quality is not too good.

Fig. 5: Typical fracture surface of a wire which has failed owing to tension-tension fatigue

The author analysed the wires in the scanning electron microscope, and the typical structure for tension-tension fatigue was found.
