# WIRE ROPE

## TECHNOLOGY AACHEN

# Negative impressions of the rope's surface in the grooves of sheaves and drums

by Dipl.-Ing. Roland Verreet

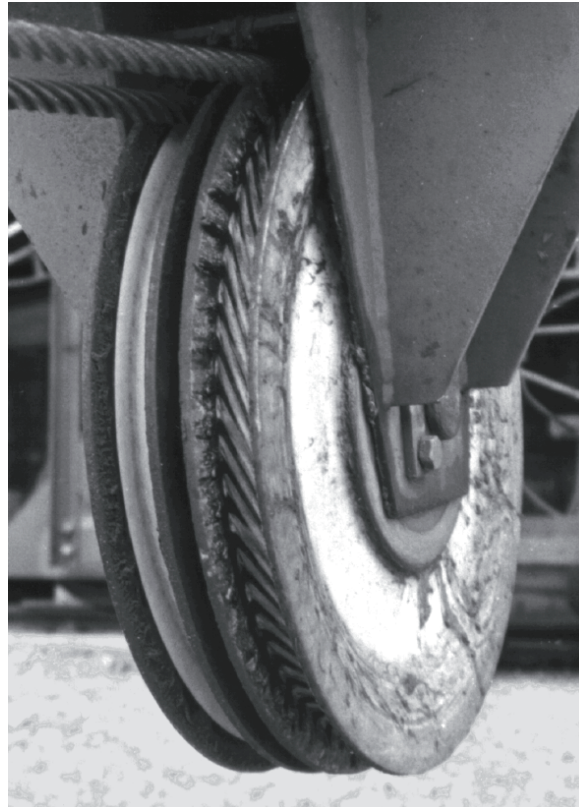
Fig. 1: Wire rope sheave with negative impressions

Quite regularly on cranes and other rope drives impressions in the grooves of the sheaves or drums can be found which look like the negative imprint of the wire rope in use (Fig. 1). The reasons for the occurrence of such damage have never been explained so far. This treatise investigates the phenomenon.

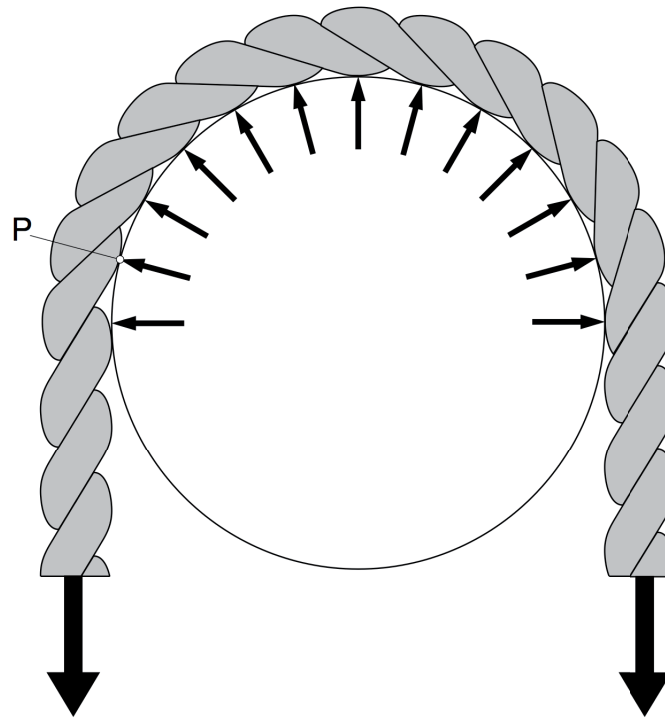
Fig. 2: Contact conditions

A wire rope rests on a sheave with the crowns of its outer strands at a limited number of contact points (Fig. 2). As in these few points the reaction forces to the line pull of the wire rope are transmitted, quite often relatively high pressure forces between the wire rope and the sheave occur in these points.

Let us first look at a sheave which during a typical operation cycle does not carry out a full rotation of  $360^\circ$ . Point P indicates the position where a strand crown lies at the beginning of the operation cycle (Fig. 2).

At the beginning of the operation cycle a strand crown rests on the groove in point P (Fig. 2). If the sheave carries out a small angle of rotation, the strand crown lying in point P will leave the bottom of the groove. After a rotation of 180° the wire rope will come to lie again in the neighbourhood of point P with a different strand crown. It is likely that the strand crown will not exactly hit point P but, for example, a point 1mm away from point P. After one more rotation of 360° the new point of contact will have moved away from point P by another millimeter. In this way it is guaranteed that for spooling of a greater rope length the contact points of the strand crowns are evenly distributed on the sheave's surface, so that the unavoidable material abrasion is evenly distributed along the circumference of the sheave.

A wire rope which has dug its own profile into the bottom of a groove will find relatively favourable bearing conditions. While initially every strand crown only had point contact with the groove (Fig. 2), it is now supported by a greater area (Fig. 5). As a result of the impression, the service life of the rope will increase in most cases.

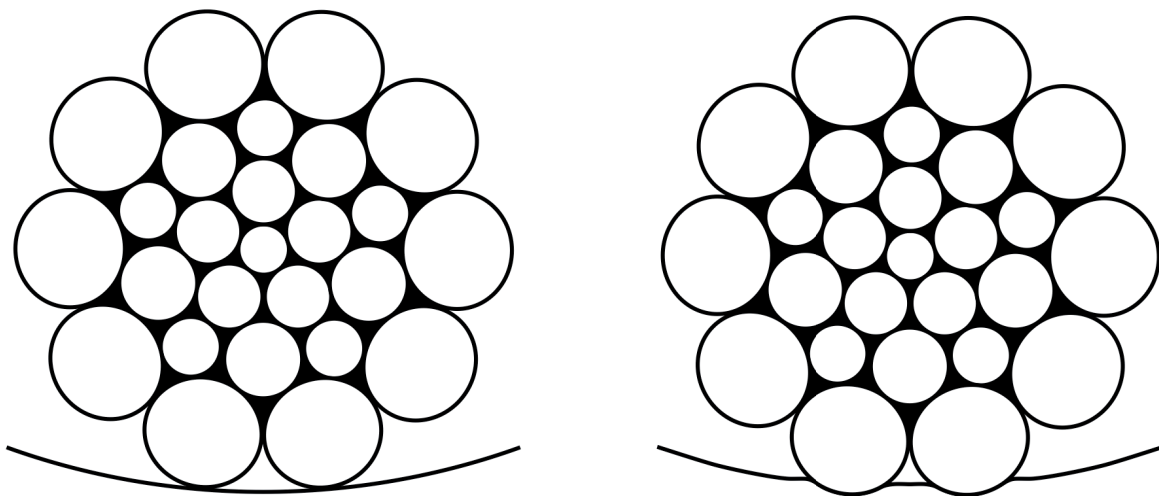
Fig. 3: Contact conditions on steel (left) and on plastic sheaves (right)

Also the use of elastic sheave materials, which are supposed to reduce the pressures in the point of contact by improving the bearing surface (Fig. 3), does not always show the desired effect. If the geometrical conditions are given, the wire rope will dig into a plastic sheave as quickly as into a steel sheave.

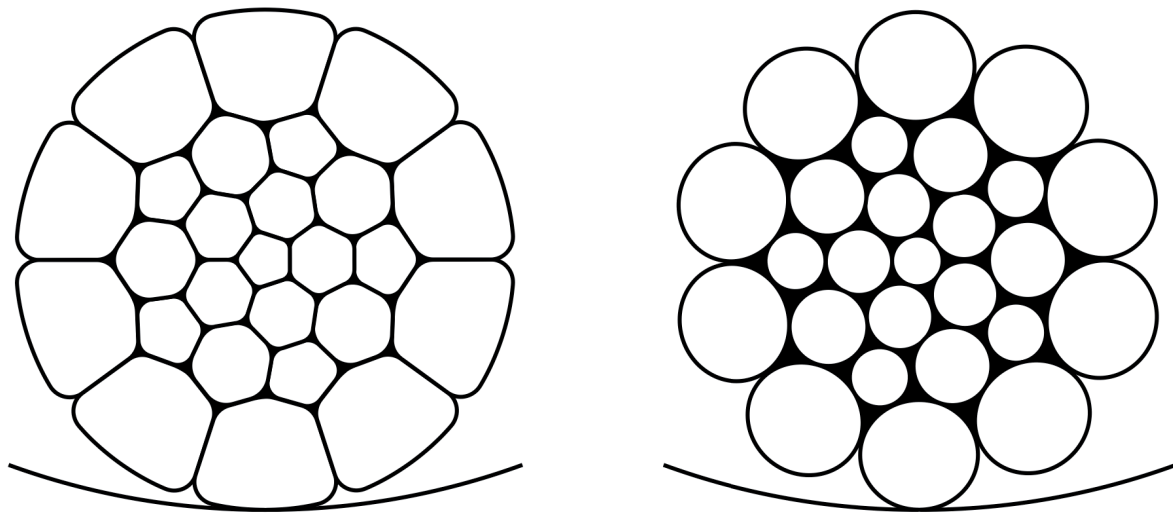
Fig. 4: Compacted strand (left) and conventional strand (right)

A very effective means against the formation of impressions in sheaves is the use of wire ropes with compacted outer strands. The outer wires of a compacted strand (Fig. 4 left) have been designed to fit the surface of the grooves much better than those of conventional outer strands (Fig. 4 right). By using ropes with compacted outer strands, the bearing surfaces are increased considerably and consequently the pressures and the material abrasion are reduced accordingly.

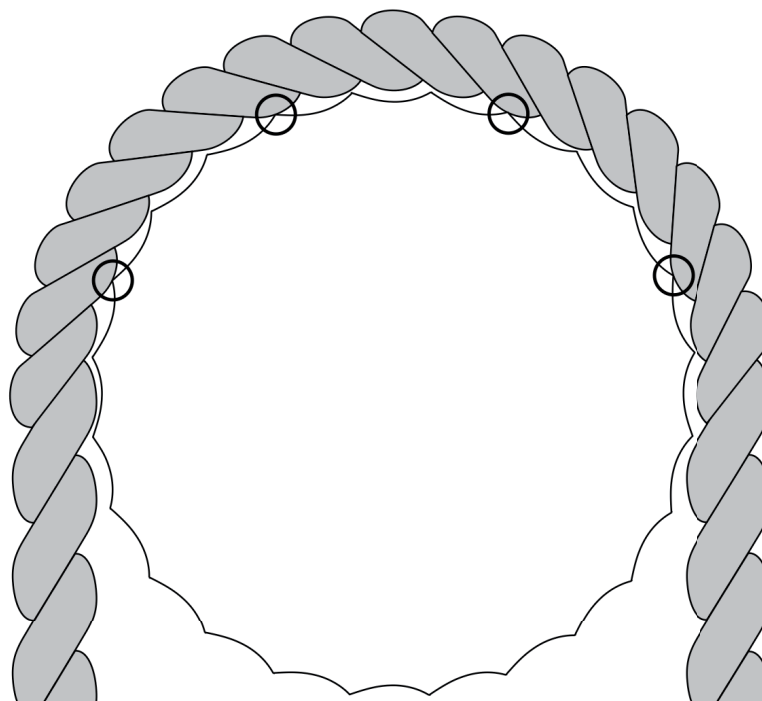
Fig. 6: Very bad contact conditions for the new rope

If the rope that has caused the impression is discarded, the replacement rope, however, will find very unfavourable conditions on the imprinted sheave, as its diameter and its lay length will not match the profile on the sheave (Fig. 6). Its very few points of contact will be subjected to very high pressures which will reduce its service life tremendously.

Additionally, the rope will try to adopt the lay length of the profile in the groove and will therefore tend to structural damage, e. g. cork screw formation. Therefore, if severe impressions are found, the sheaves should be replaced or machined when a new rope is installed.
