WIRE ROPE

Are you safe?

by Dipl.-Ing. Roland Verreet

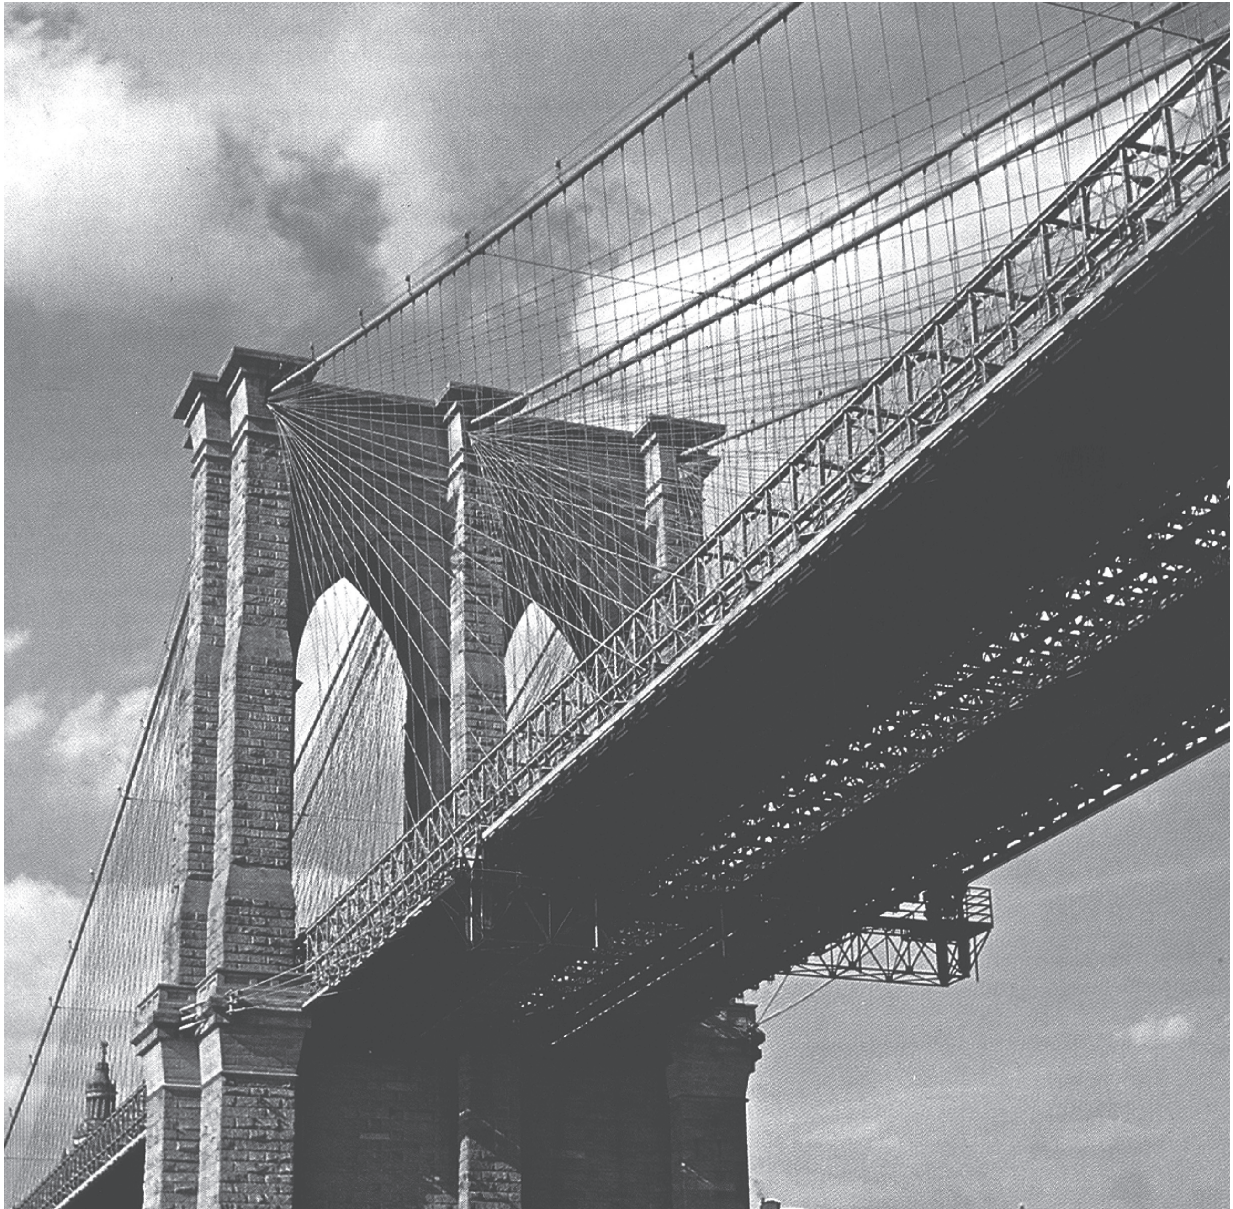
Fig. 1: The Brooklyn Bridge

John Roebling, the designer of the East River Suspension Bridge, today better known as the Brooklyn Bridge (Fig. 1), was not only one of the leading bridge builders of his time, he was also the first manufacturer of wire rope on the American continent.

Consequently, the suspension ropes of the Brooklyn Bridge were also designed with a safety factor of 6. During the time the bridge was being built, John Roebling died, and his son Washington Roebling continued his work. After the stone towers were completed in 1877, the main cables were spun in place. Wire by wire was pulled over the pylons so that it could adopt its natural catenary, and then it was bundled with the other wires. This procedure, invented by John Roebling, allowed the wires inside the bend to be shorter and the wires outside the bend to be longer than those in the center, guaranteeing a uniform stress distribution over the cable cross section.

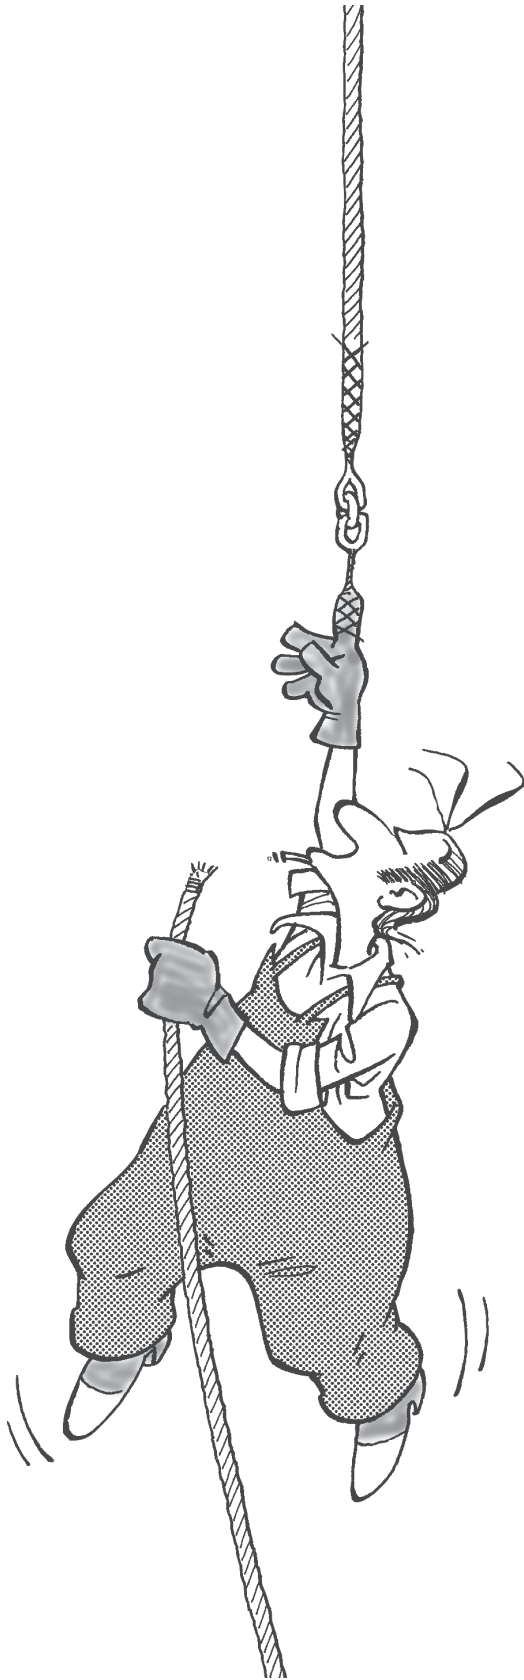
Fig. 6: Installing a wire rope using a sock (incorrect method)

Rope socks or 'Chinese fingers' are made of braided wires or strands and are used to install electrical cables or steel wire ropes (Fig. 6). One day the author was present when a hoist rope was installed on an offshore crane. The rope sock was pulled over the rope end, and the fitters started to secure the sock by a greater number of wire seizings (Fig. 7 right).
