WIRE ROPE TECHNOLOGY AACHEN GMBH

WHAT WE CAN DO FOR YOU

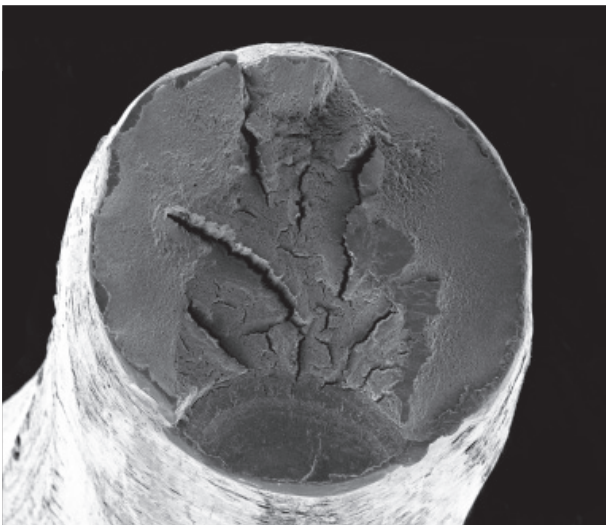
This wire suffered from a certain amount of fatigue (lower section) when it broke due to an overload. Scanning electron microscope (SEM) photograph.

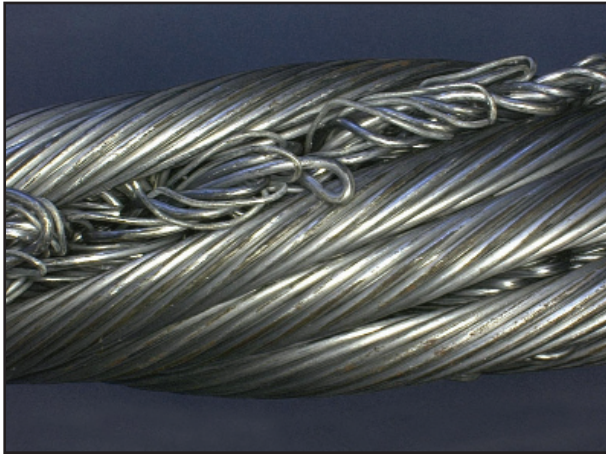
Whatever your rope damage looks like, we will be able to tell you how to avoid it. A tilted block caused this damage.

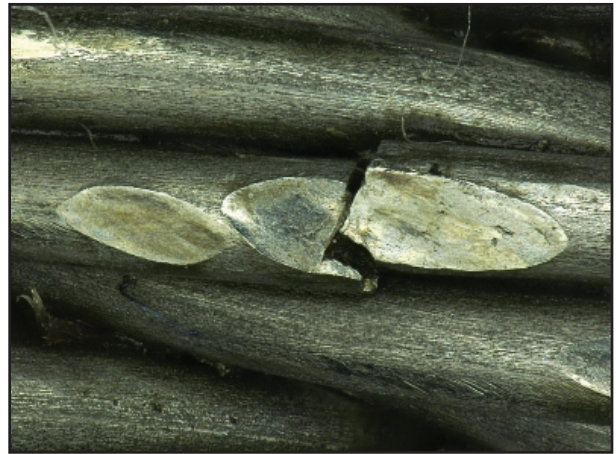
Wire breaks on the IWRC of a steel wire rope at the contact points with the outer strands. This work was done for CERN, Geneva.

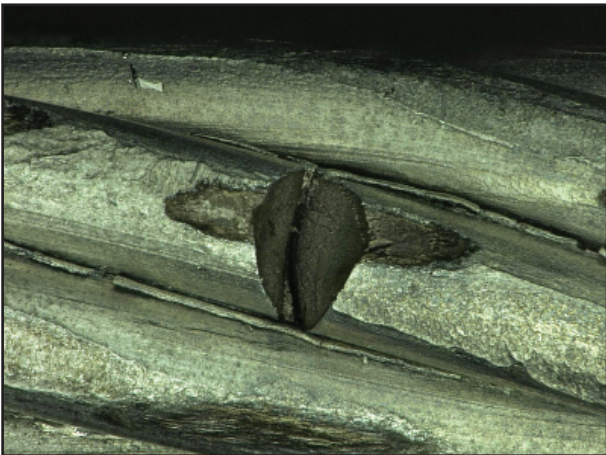
„Double“ wire break in a tension-torsion application. This is a digital microscope multi-focus photograph with colour information.

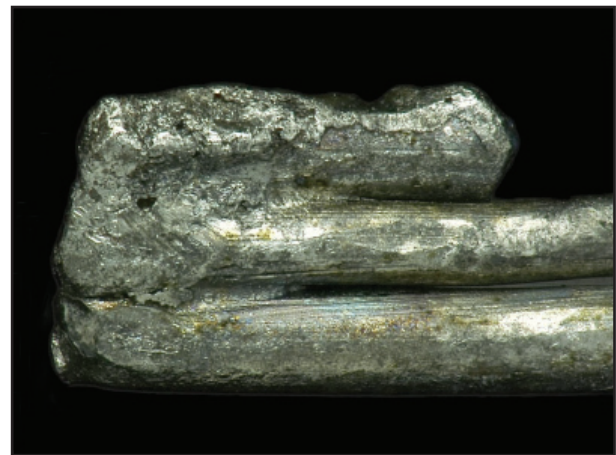
Five people lost their lives in the far east when a hoist rope failed. The rope had been damaged by a lightning strike the day before. Wire diameter 0,3mm.

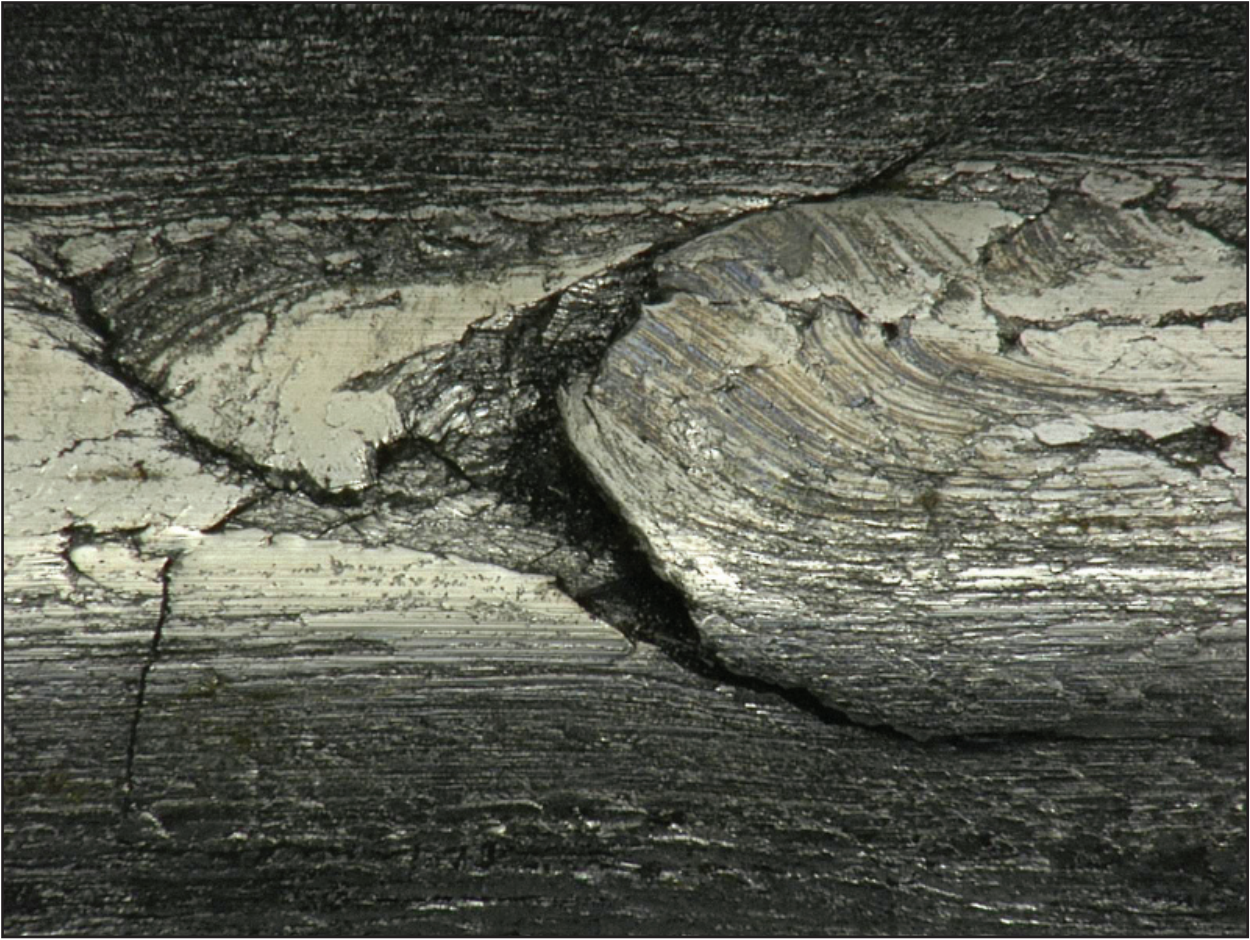
This steel wire has a surface defect (often referred to as Crow's Feet). The defect was caused during the drawing process. If such a defect is not detected by the quality control engineers of the rope manufacturer it might lead to premature wire breaks. Multifocus digital microscope photograph.

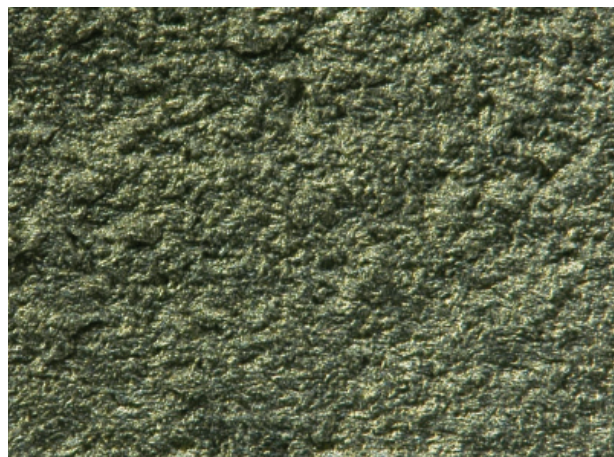
Fatigue break surface (digital microscope 900x). These orders of magnification are not possible with ordinary optical microscopes.

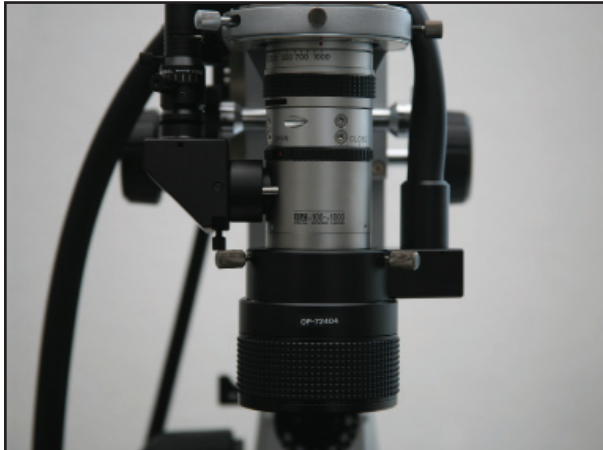
We analyze wires with two digital microscopes with multifocal capabilities and magnifications ranging from 5x to 1000x.

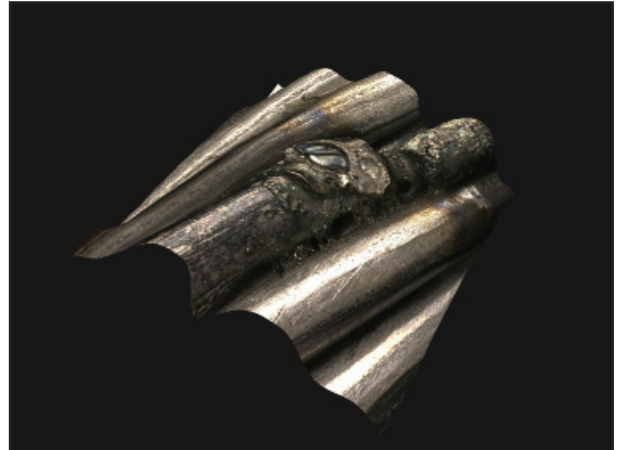
Damage caused by lightning on a steel wire rope. 3D photograph. This 3D photograph was made for NASA.

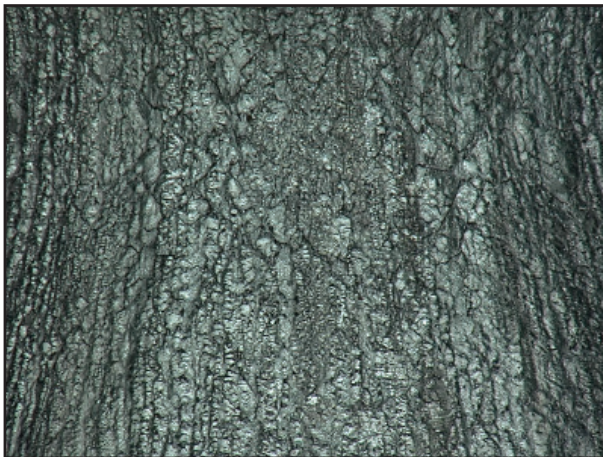
Wire surface near an overload break. The once-smooth surface has wrinkled because of the reduction in the wire's diameter. Lab test.

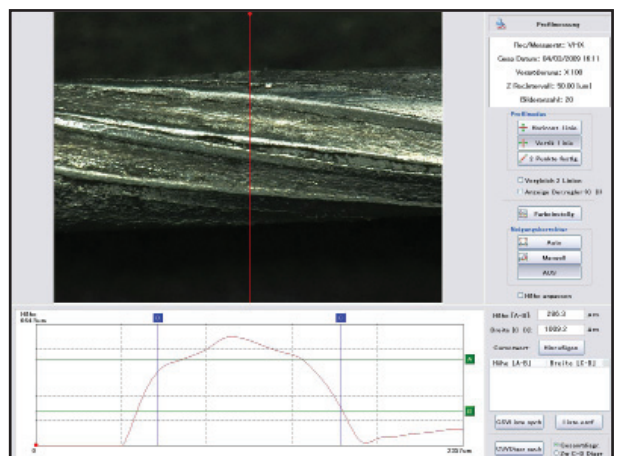
The 3D imaging technology enables us to analyse the cross sections of individual wires and to take measurements.

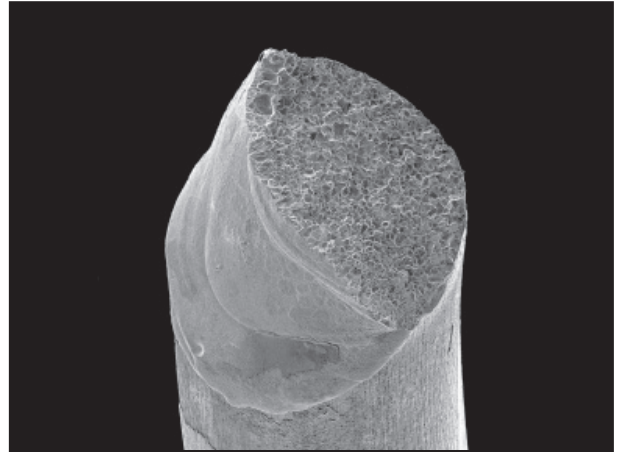
An outer wire of a rope struck by artificial lightning. The structure has recrystallized. Work for NASA.

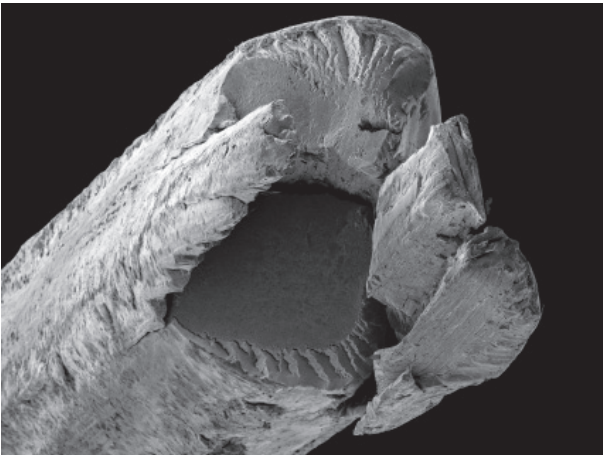
Mechanical damage to a wire. The rope had jumped a sheave (same rope as above). The center of the wire failed as a shear break.

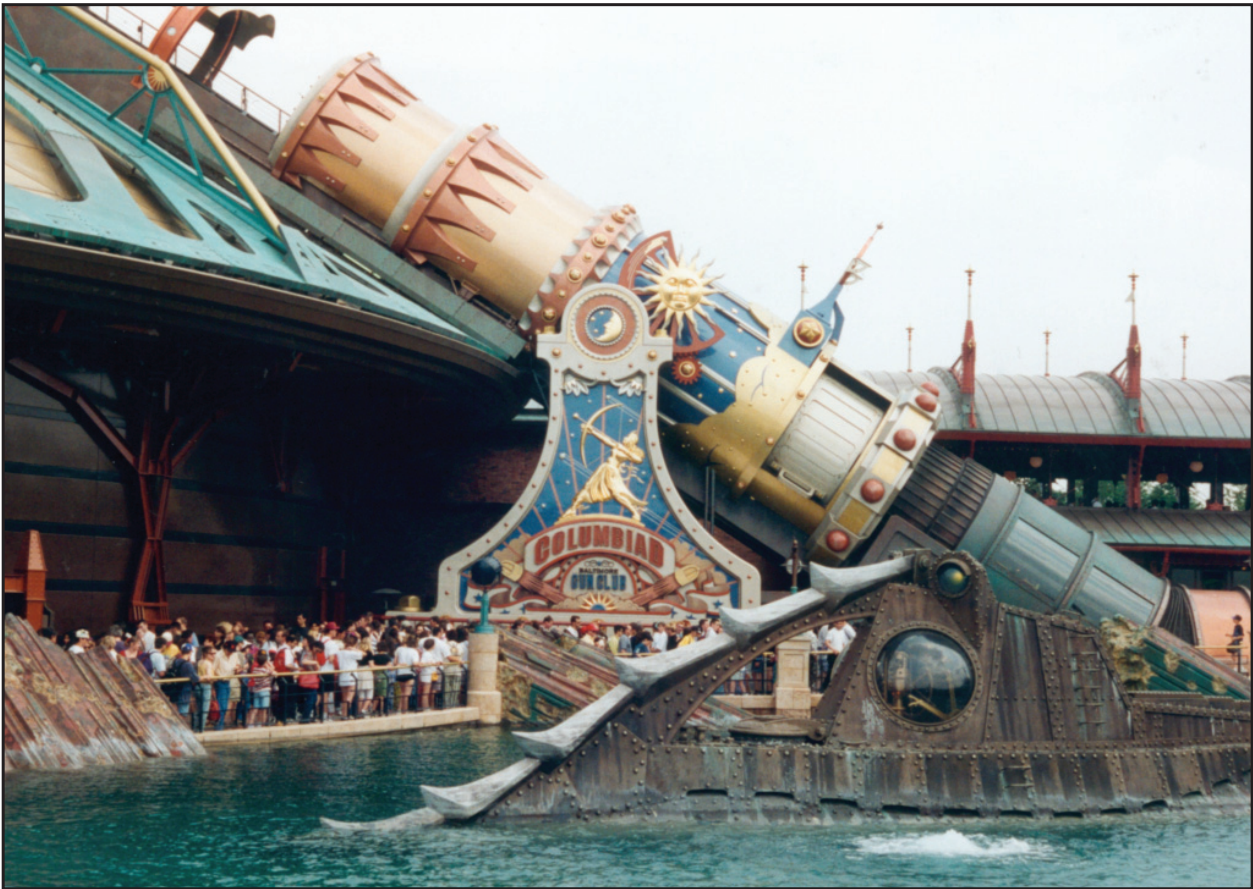
Over the last 25 years we have designed or helped improve a great number of spectacular reeving systems. One example, shown here, is the catapult of the Space Mountain ride at Eurodisney, Paris.

Almost every wire rope expert was convinced that, because of the high dynamic forces, such a catapult could never work using a wire rope. And yet we made it happen. The rope driven catapult has now shot more than 100 million people into the dome without a single rope-related incident.

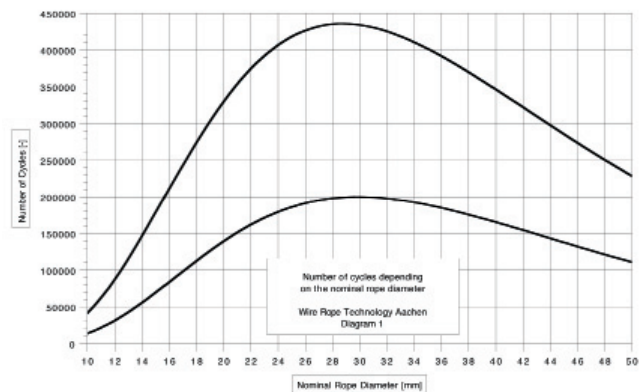
We can plot the rope life until discard (lower curve) and until break, as a function of the rope diameter. This will enable you to choose the optimum rope diameter for your system.

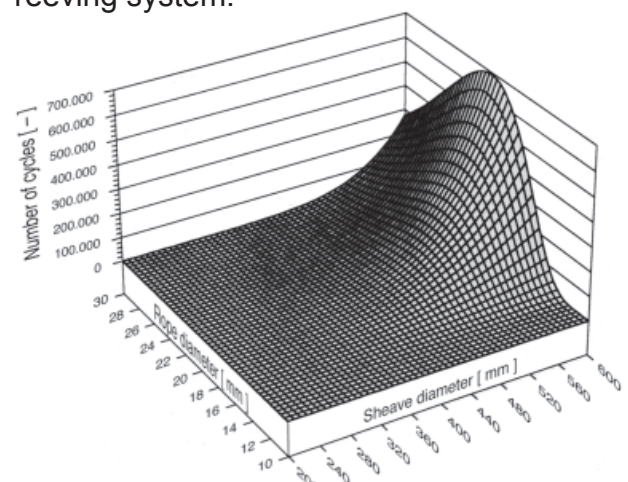
We can plot the fatigue life in 3D as a function of two different parameters in order to illustrate which parameters must be changed in order to achieve optimum performance.

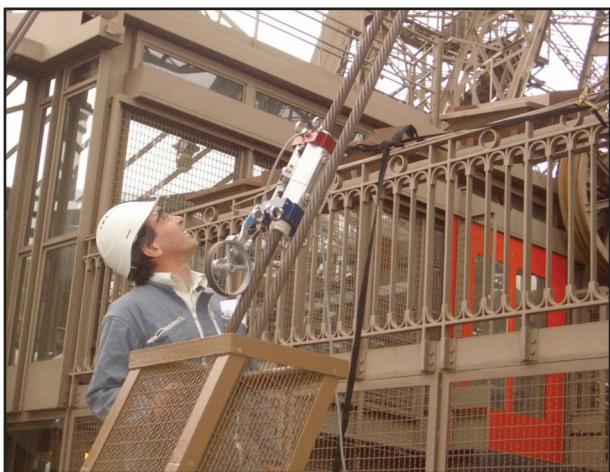
Jean-Marc Teissier (photo) and Roland Verreet inspecting the elevator ropes on the Eiffel tower in Paris using NDT equipment.
