# CASAR<sup>®</sup>

## Wire Rope Forensics

by Dipl.- Ing. Roland Verreet and Dr. Isabel Ridge

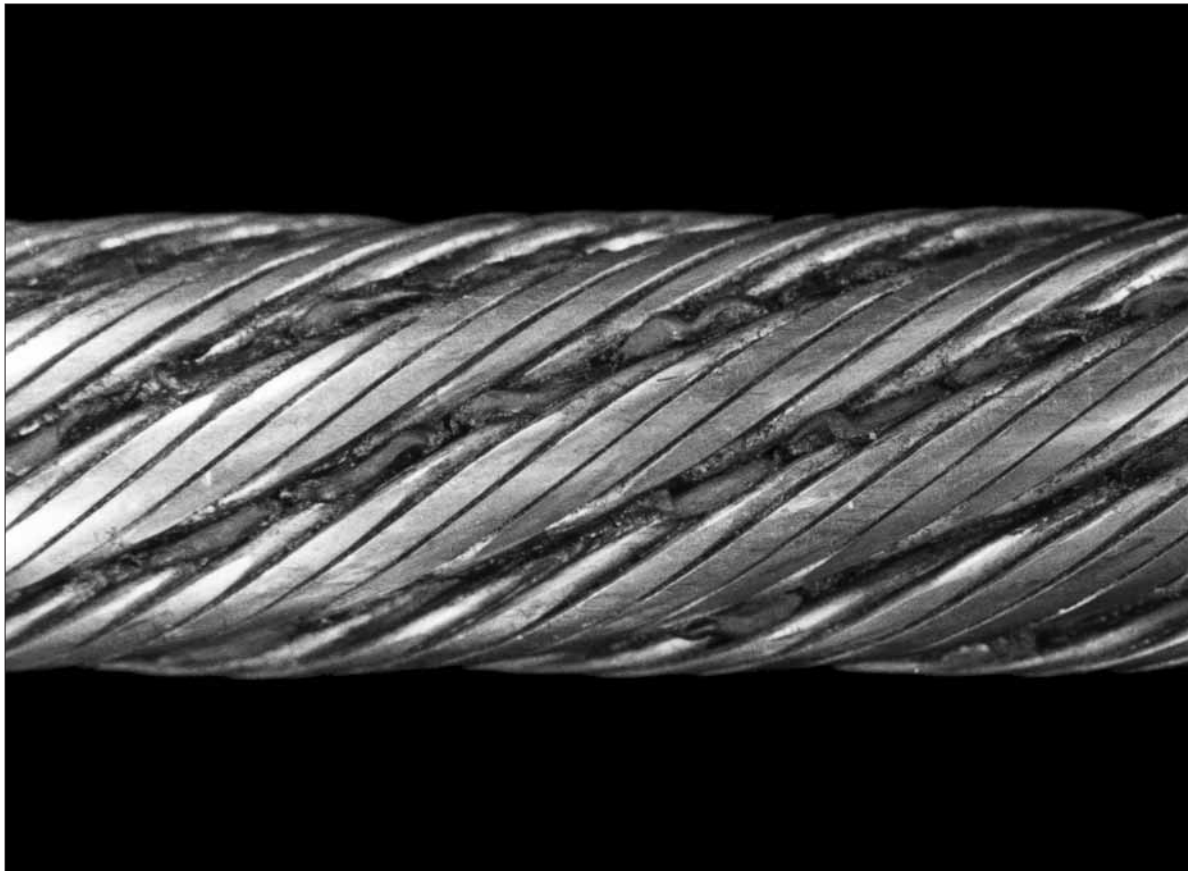
Fig. 1: A Langs lay rope with a great amount of uniform mechanical wear. Please note that the rope does not exhibit any fatigue breaks. The bearing surface on sheaves and drums has increased due to the mechanical wear.

As long as the rate of diameter reduction due to wear is higher than the fatigue crack propagation rate, ropes will not develop fatigue wire breaks (Fig. 1, Langs lay, and Fig. 4, regular lay). Once the rate of diameter reduction slows down, fatigue breaks will appear (Fig. 9).

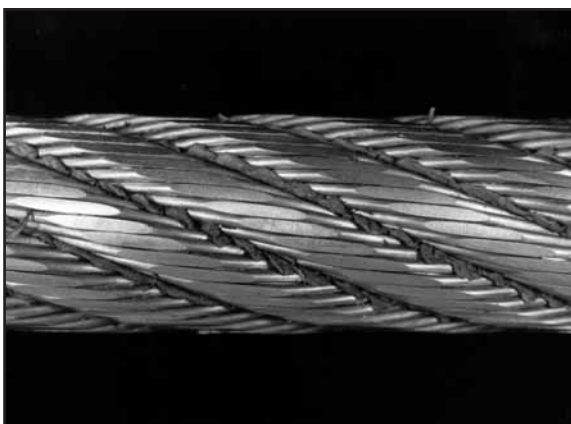
Fig. 4: Regular lay rope with a great amount of uniform mechanical wear. Please note that the rope does not show any fatigue breaks.

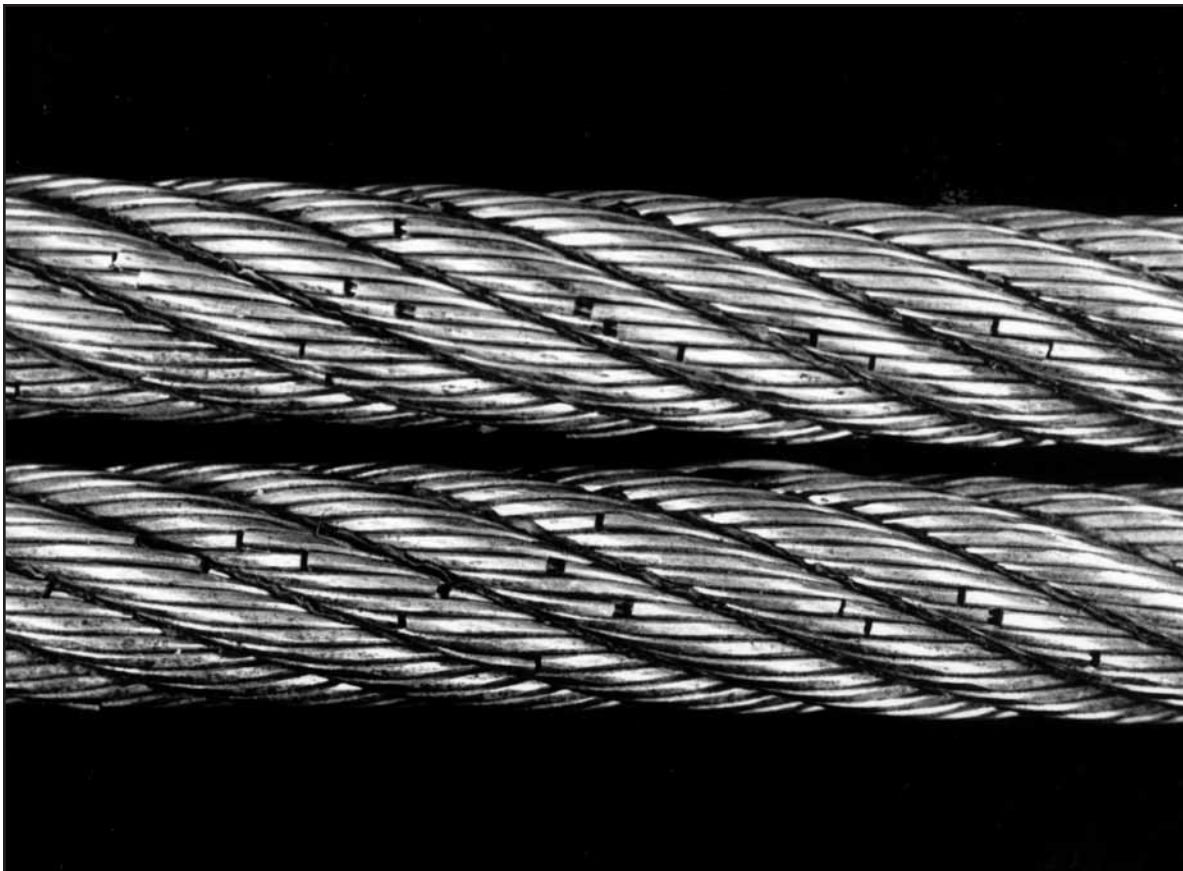
Fig. 8: Bending fatigue breaks on ropes made out of compacted outer strands. The distribution of bending fatigue wire breaks is typically random.

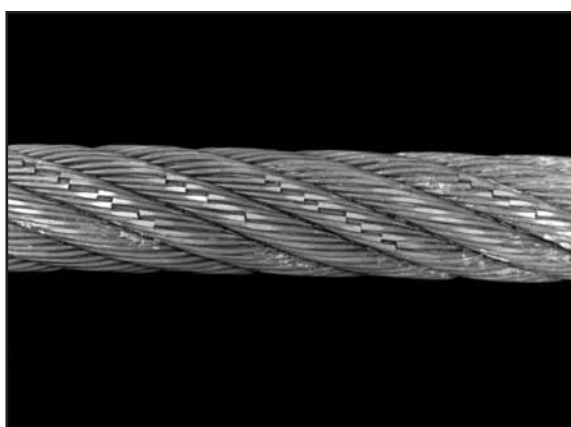
Fig. 11: Three adjacent strands with fatigue breaks followed by one without indicate uneven load sharing or a pulled-in strand.

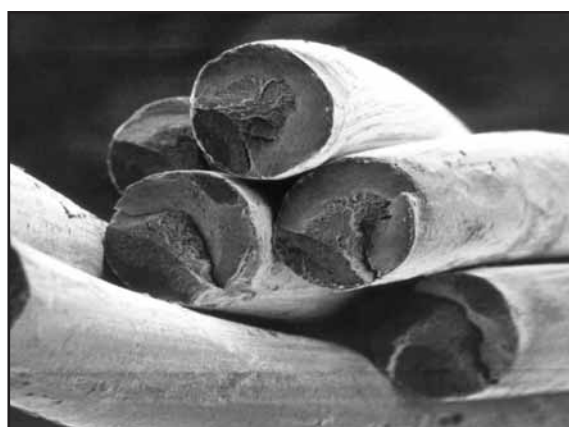
Fig. 12: Fatigue cracks starting at the points of contact of individual wires. The cracks became visible after destroying the strand in a pull test.

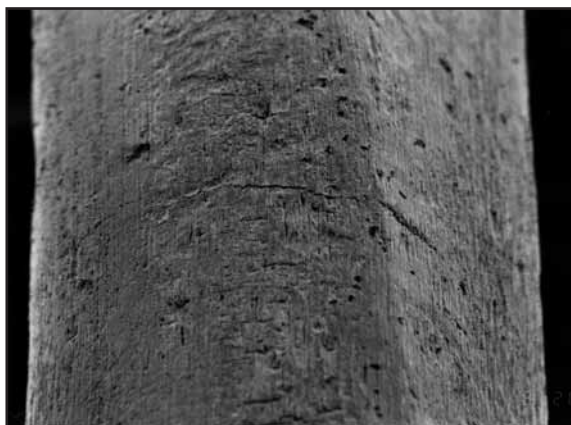
Fig. 13: Surface corrosion often initiates the formation of fatigue cracks.

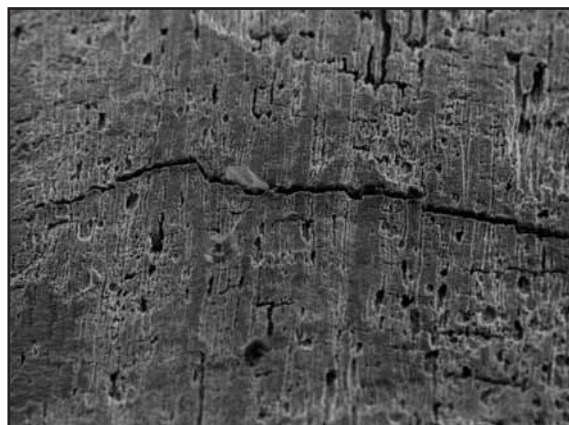
Fig. 14: Pitting and corrosion associated with a fatigue crack (detail of Fig. 13).

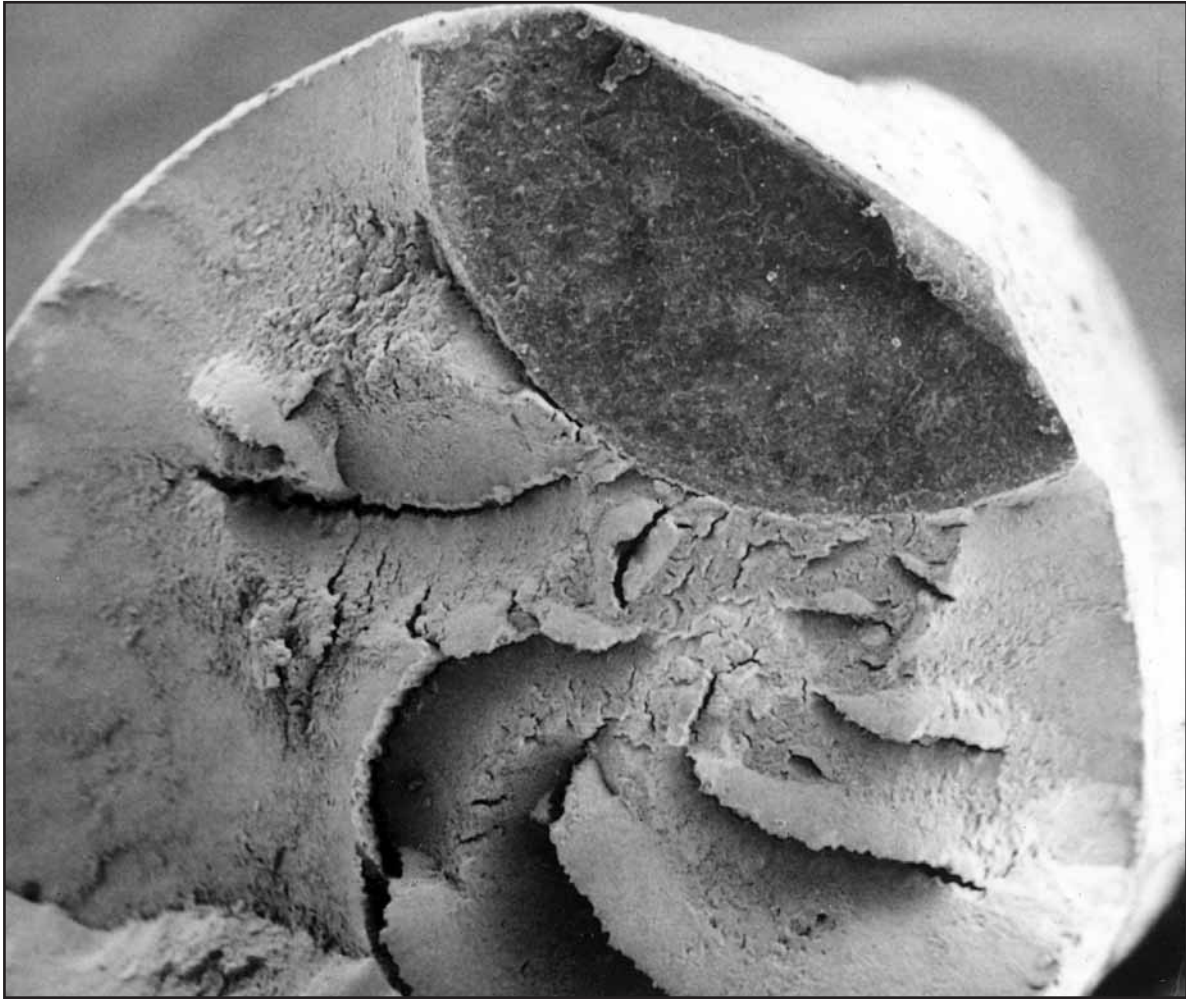
Fig. 15: A fatigue crack starting at the point of contact with a sheave. Obviously the crack propagated concentric to its point of initiation. The crack only became visible after destroying the strand in a pull test.

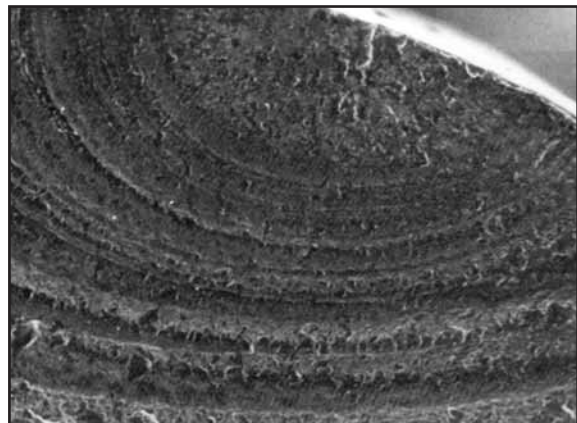
Fig. 17: The fatigue crack radiates out from the origin as a series of concentric rings (termed rest lines, beach lines or striations).

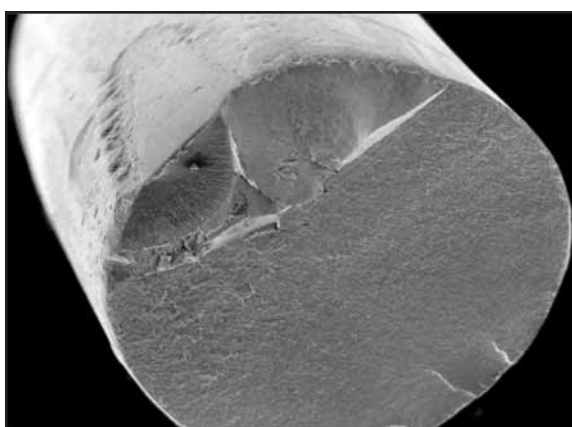
Fig. 20: A fatigue crack. The point of origin and the concentric propagation of the smaller fatigue crack is clearly visible.

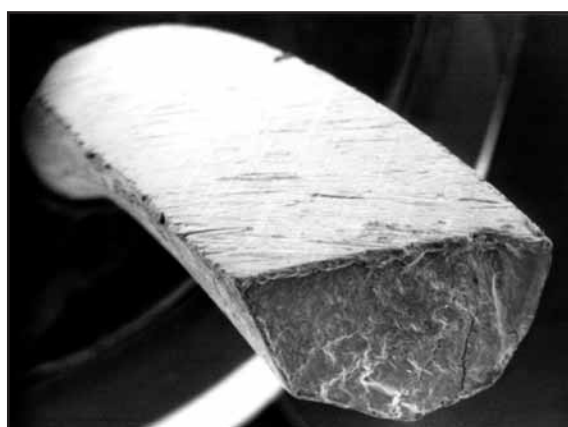
Fig. 21: Severely worn wire with a fatigue break.

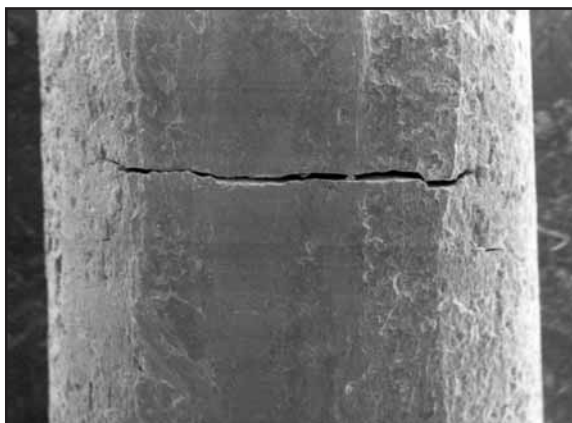
Fig. 22: A fatigue crack.

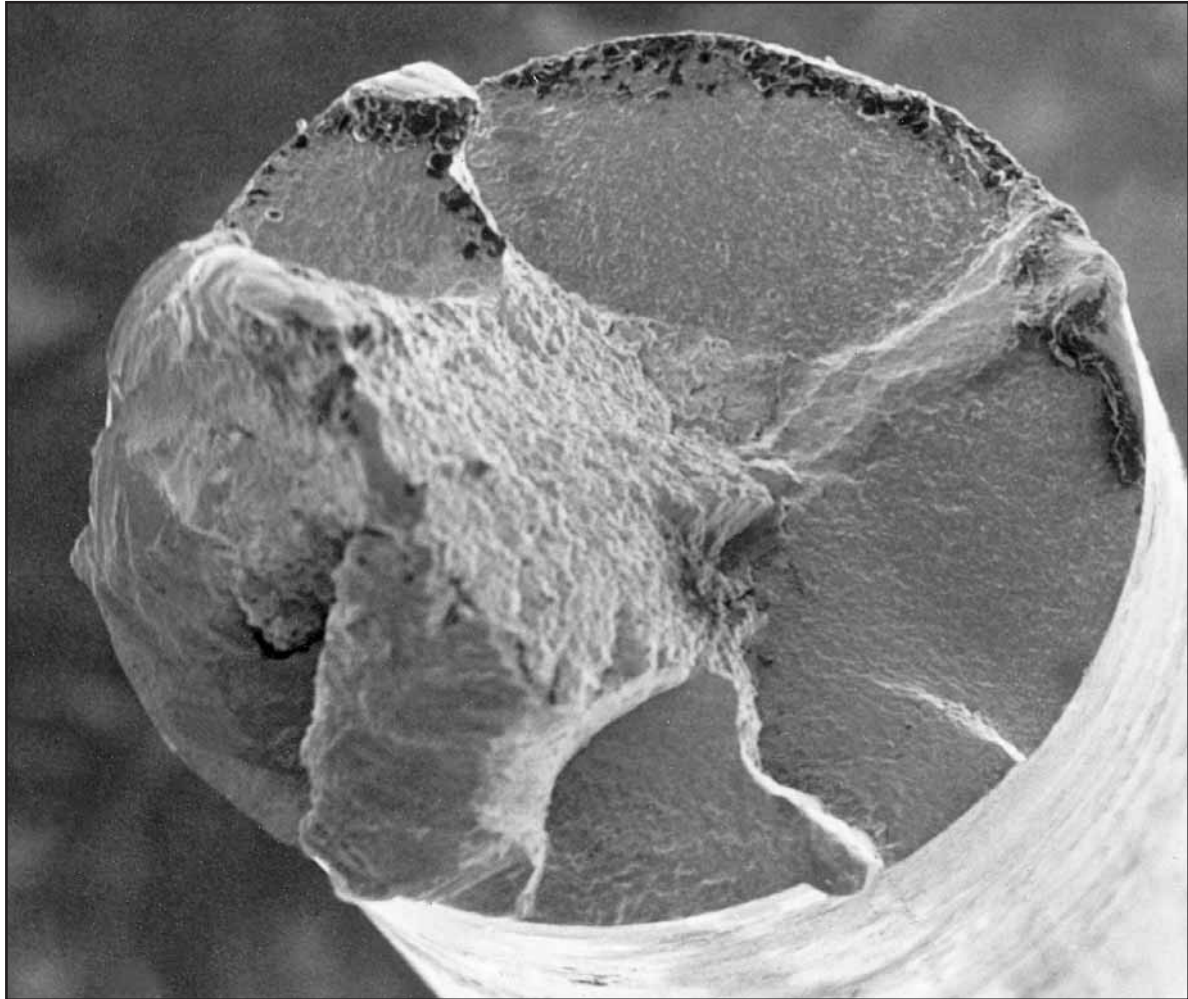
Fig. 24: Wire fatigued in rotary bending fatigue test. The cracks initiate from all around the circumference.

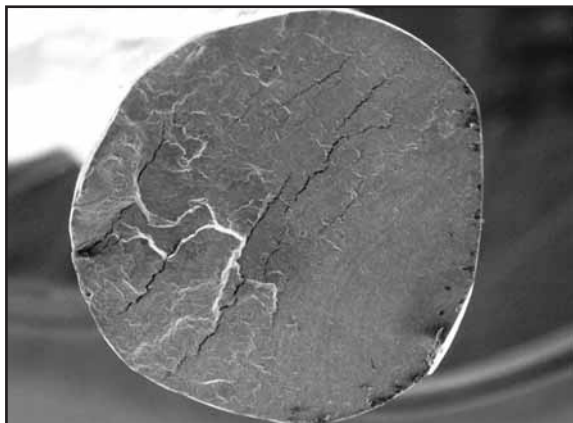
Fig. 25: Fatigue crack. The wire fatigued under the influence of both traction and compression.

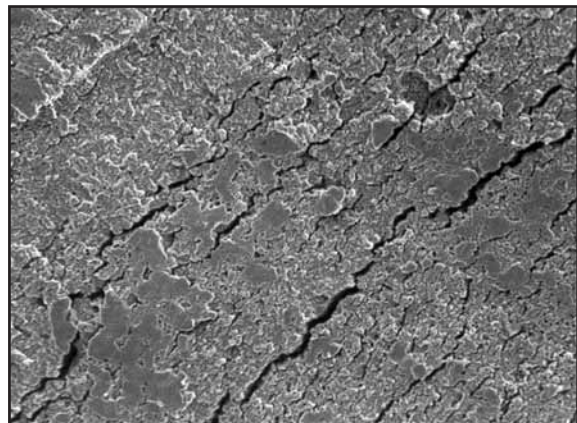
Fig. 26: Enlarged view of the crack shown in Fig. 25. The fatigue surface shows secondary deformations due to compression.

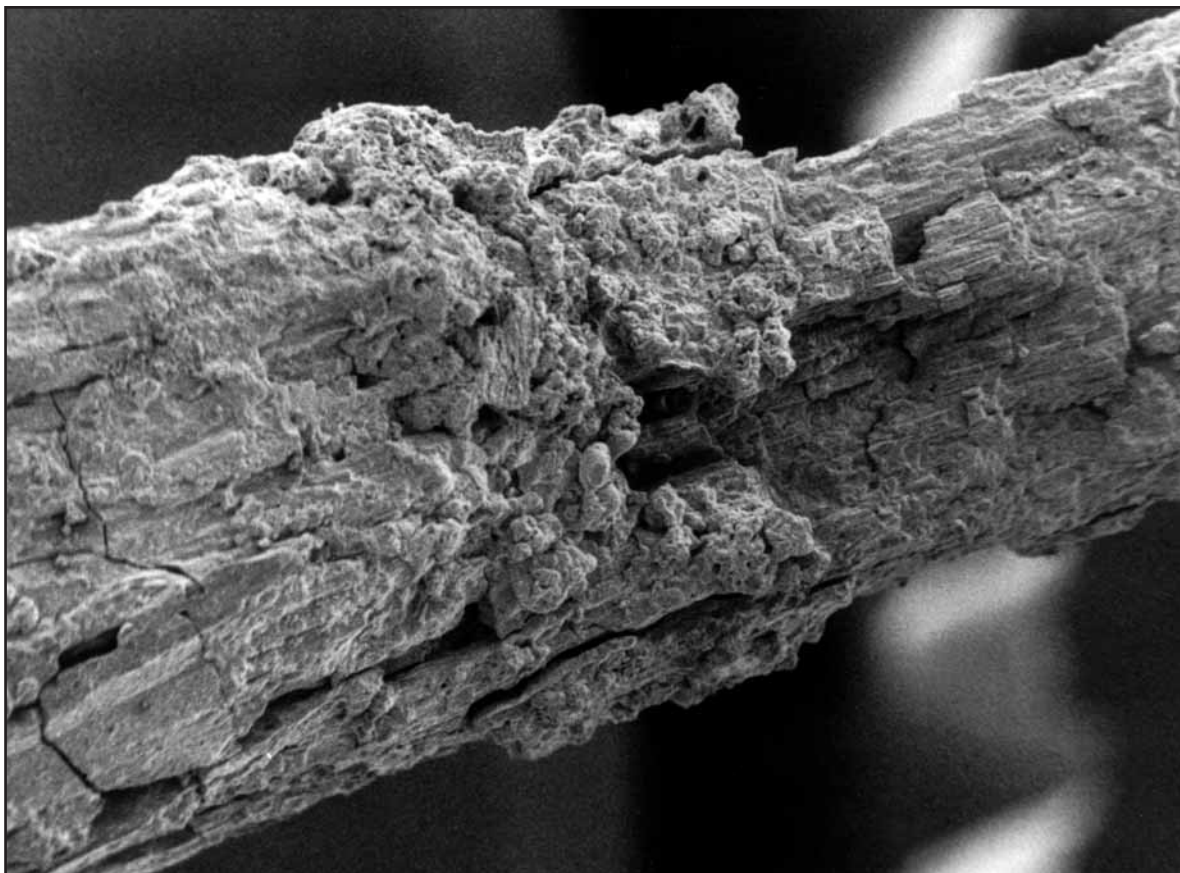
Fig. 27: Severe uniform corrosion (atmospheric corrosion). Static ropes and ropes operating in a marine environment should be galvanized and well lubricated. A plastic coating between the steel core and the outer strands will protect internal rope elements.

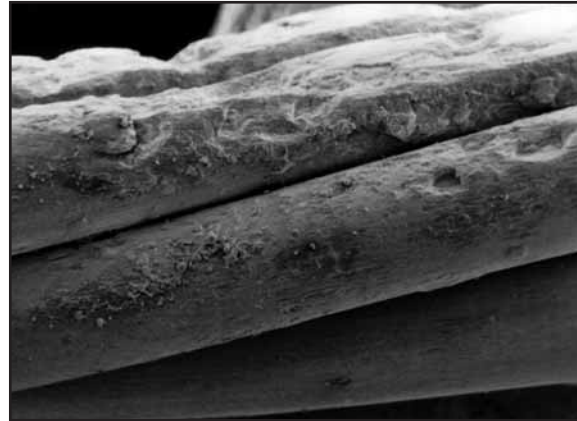
Fig. 29: Pitting corrosion (local corrosive attack creating deep pits).

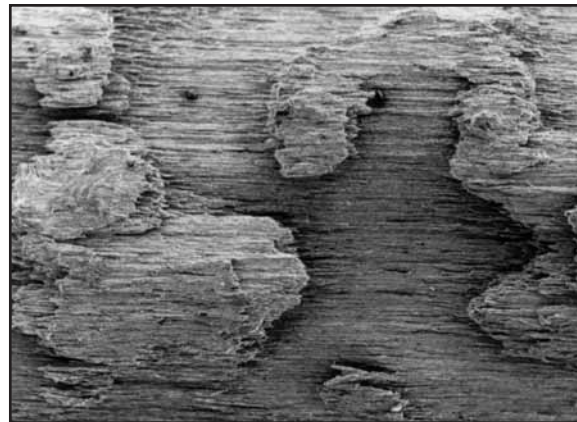
Fig. 31: The highly orientated microstructure of drawn high tensile wire becomes apparent in the corroded state.

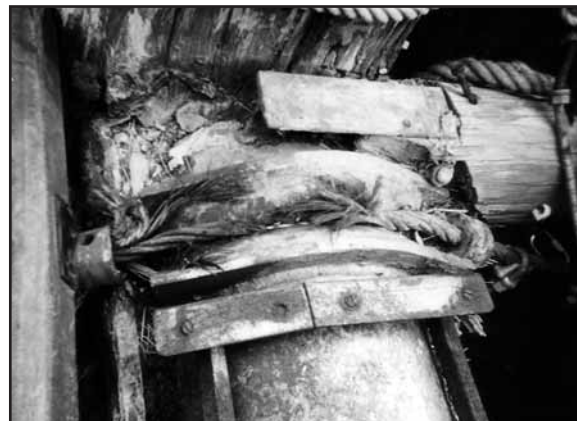
Fig. 33: Saddle of a bridge in an amusement park. Standing water (e.g. trapped on saddles) causes severe local rope corrosion.

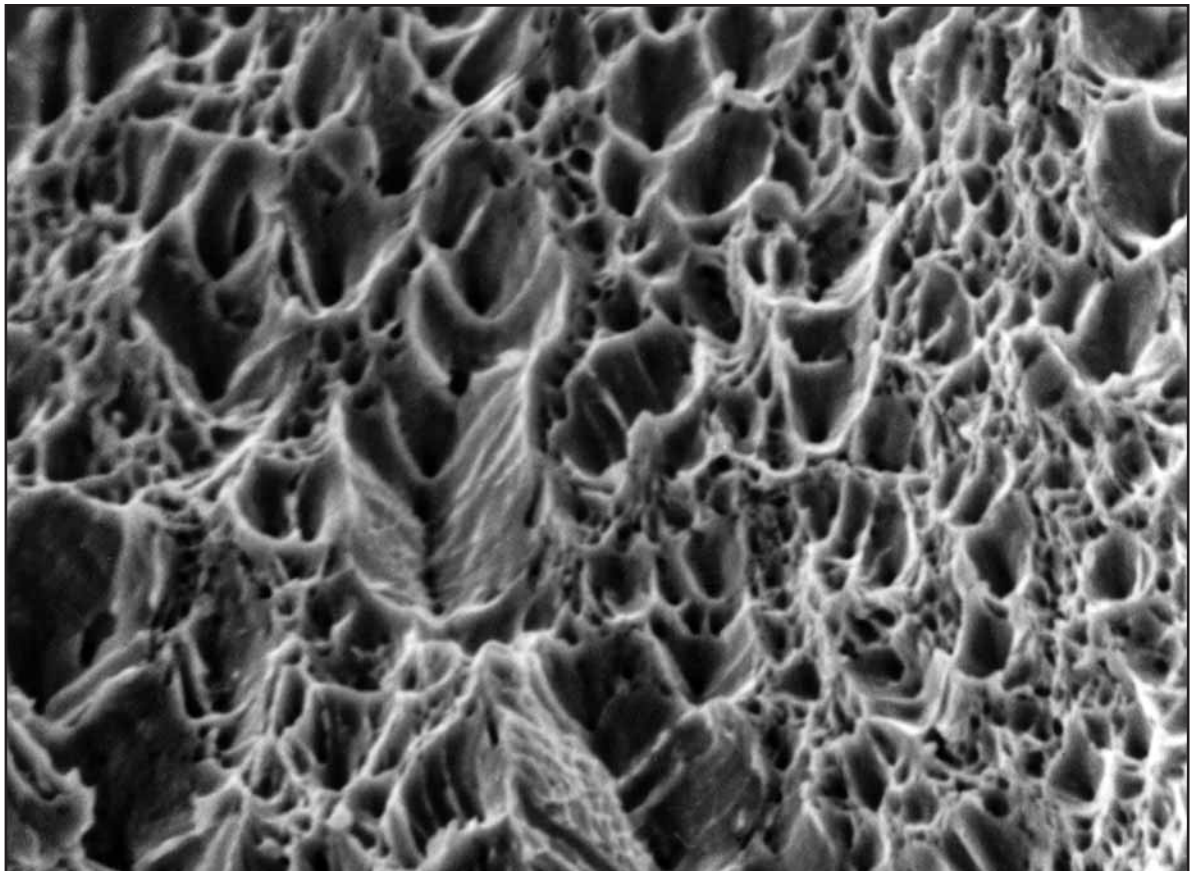
Fig. 34: Ductile dimple formations in the steel microstructure are a clear indication of a tensile overload (enlarged view of the break surface of a cone centre).

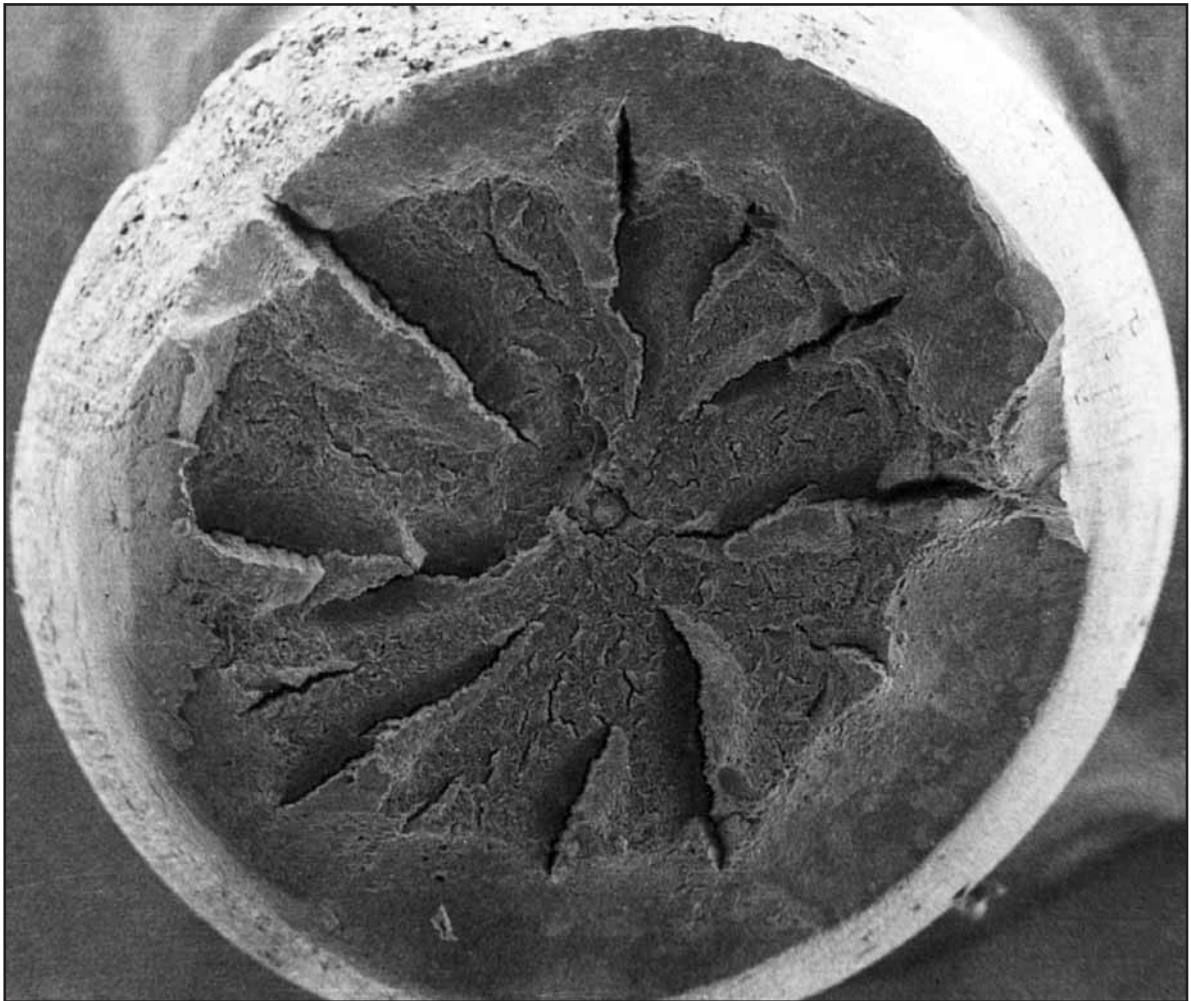
Fig. 41: End view of the cone half of a tensile overload break. The inner cone has failed due to tensile stresses before finally the outer ring fails in shear.

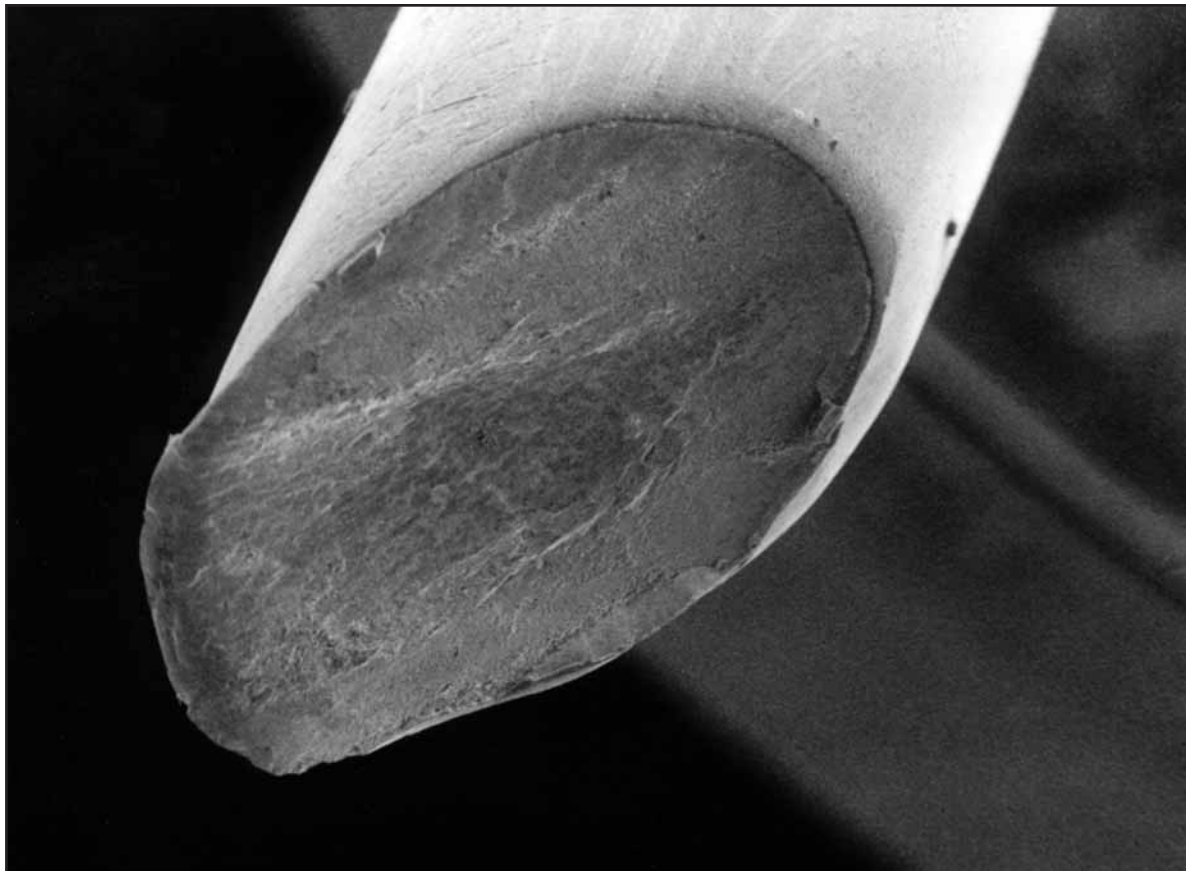
Fig. 44: A typical 45° shear break. Please note that there is a small reduction in diameter at the edge of the fracture surface, but it is small compared with the necking associated with a ductile tensile cup and cone failure (see e.g. Fig. 36).

Figure 44 shows a typical shear break. The fracture surface is fairly smooth in appearance. Please note that there is a small reduction in diameter at the edge of the fracture surface, but it is small compared with the necking associated with a ductile tensile cup and cone failure (see e.g. Fig. 36).

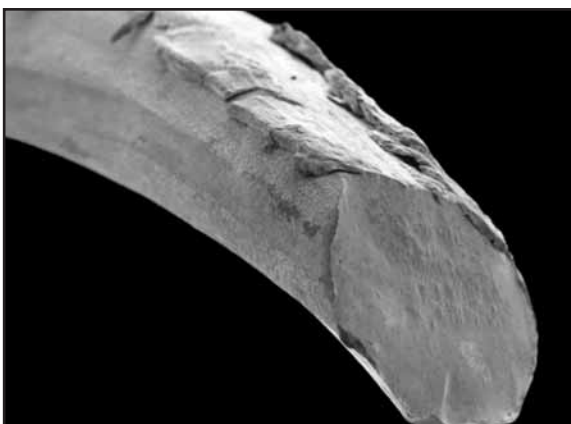
Fig. 47: High transverse loading initially caused severe plastic wear. Finally the wire failed in shear.

Quite often a wire shear failure will be associated with wear (Fig. 45), plastic wear (Fig. 47), or fatigue (Fig. 48).

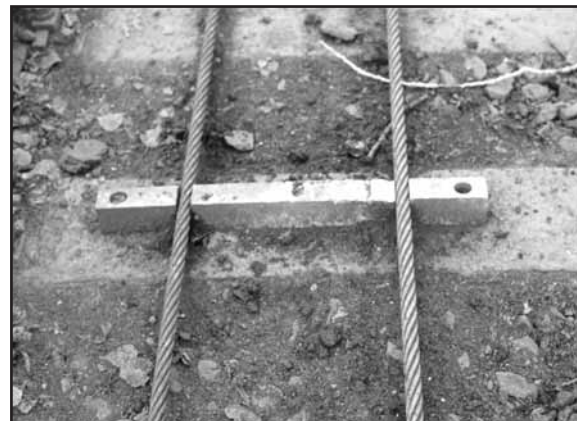
Fig. 53: ...not to forget worn support plates.

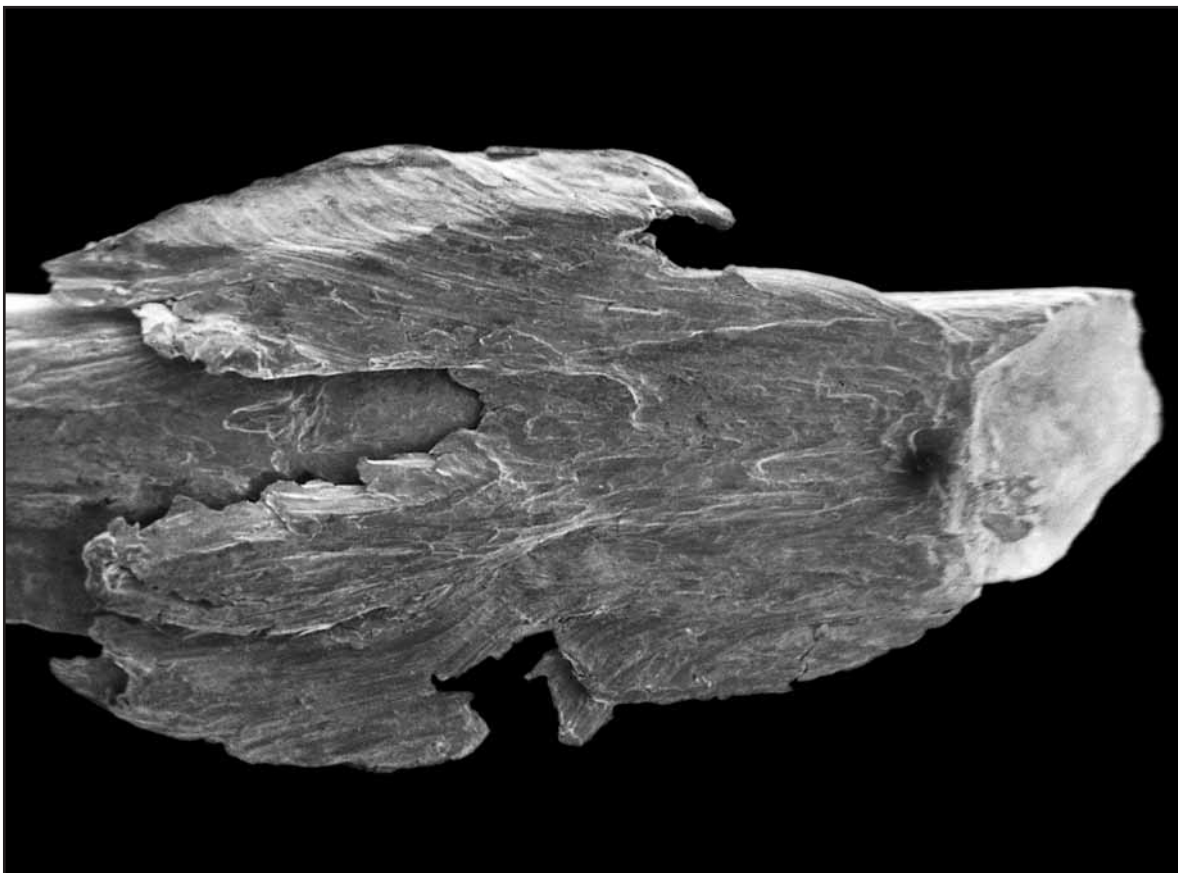
Fig. 54: Severe plastic deformation caused by the rope hitting a steel structure. The high axial line pull combined with high transverse loading, has finally lead to the shear failure of the wire.

Steel wire ropes are often mechanically damaged during service. The rope might hit a steel structure, thereby locally damaging some outer wires (Fig. 54), or it might be dragged along a hard surface, creating a great amount of mechanical wear. As an example, Fig. 55 shows a rope which has been pulled over a stuck sheave.

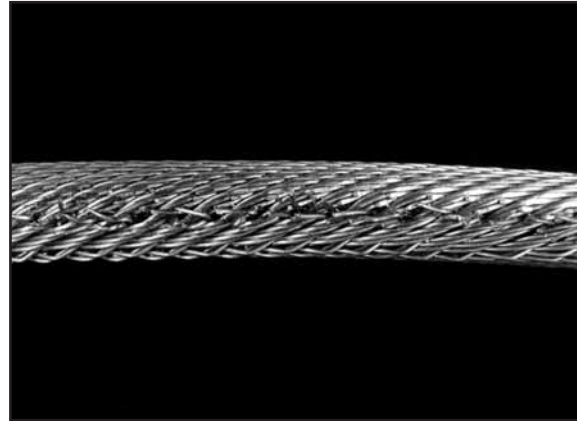
Fig. 56: Rotation resistant rope damaged by being dragged over the rim of a sheave.

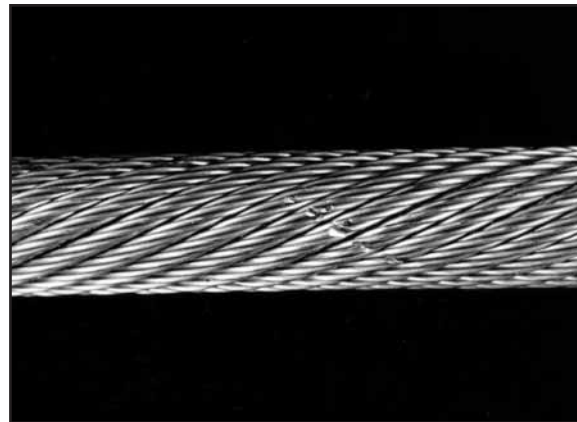
Fig. 58: Rotation resistant rope damaged by striking a sharp edge.

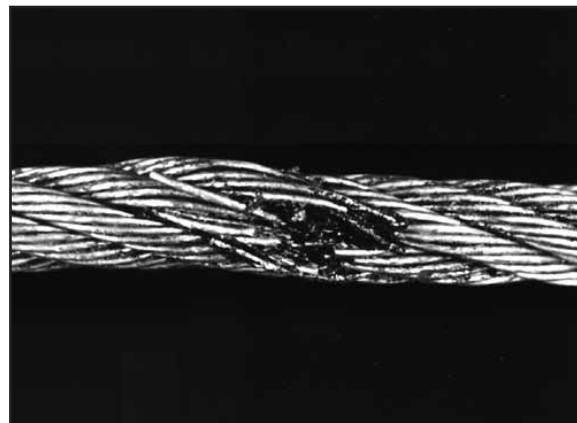
Fig. 60: Six strand rope damaged by striking a sharp edge. This rope is in a dangerous condition and must be discarded.

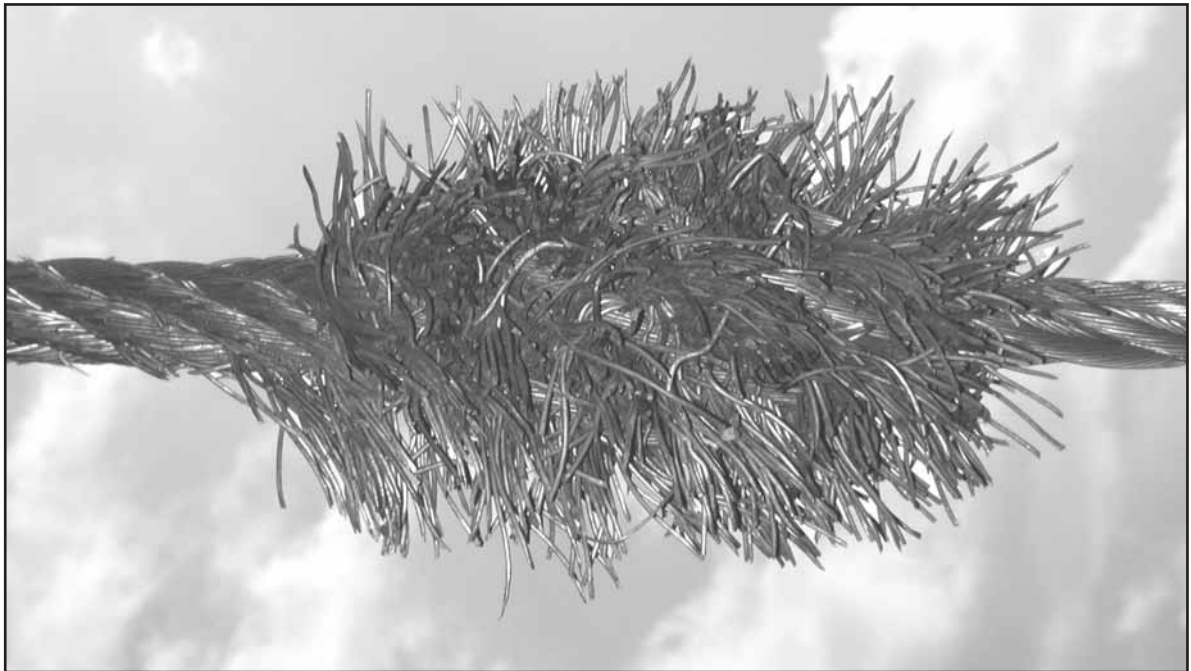
Fig. 61: Closing rope of a grab crane. All the outer wires had broken due to severe abrasion. The flared exit funnel of the grab has pushed all loose wire ends along the rope length to one location, creating this impressive hedgehog.

Fig. 61 shows a closing rope of a grab crane. All outer wires had broken due to severe abrasion. The flared exit funnel of the grab has pushed all the loose wire ends along the rope length to one location, creating this impressive hedgehog.

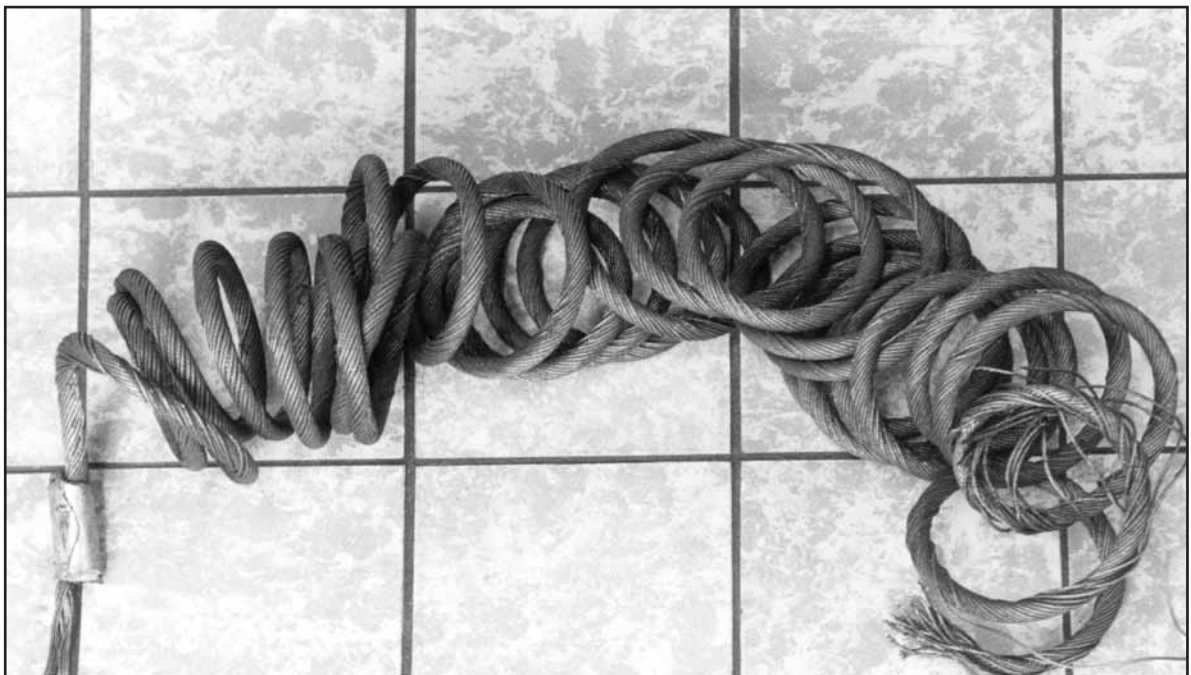
Fig. 62: Ropes that have been pulled over a sharp edge have a tendency to coil when unloaded.

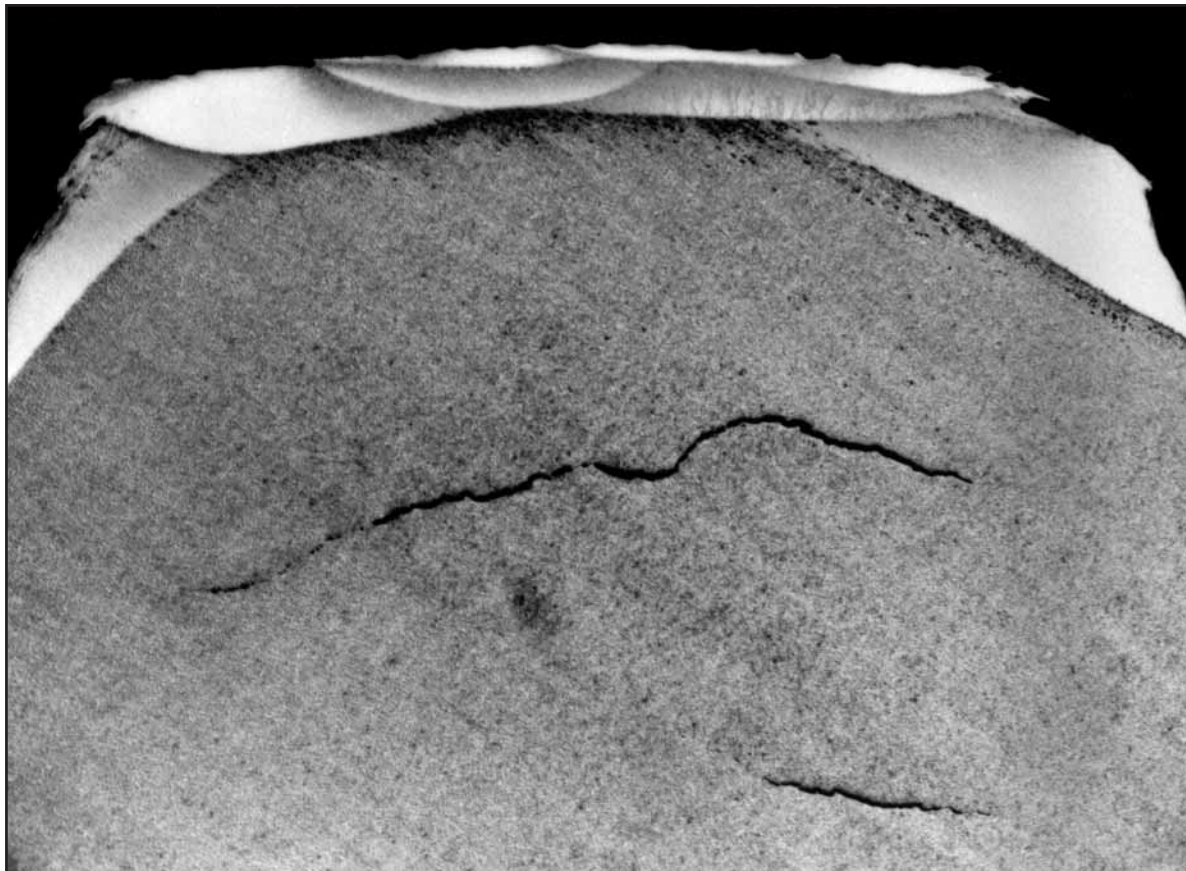
Fig. 63: This outer wire of a rope has been dragged along the edge of a cargo hatch several times when unloading a ship. Each time a new layer of martensite formed, partly tempering the underlying martensite layers. The thickness of the martensite layer is approx. 0.05 mm.

In steel wire ropes, martensite is often found as a thin layer on the crowns of rope wires where these have been dragged over a hard surface (Figs. 63 and 64). This thin martensite layer will easily crack when the wire is being bent, initiating a fatigue crack which will rapidly propagate (Figs. 66 and 67).

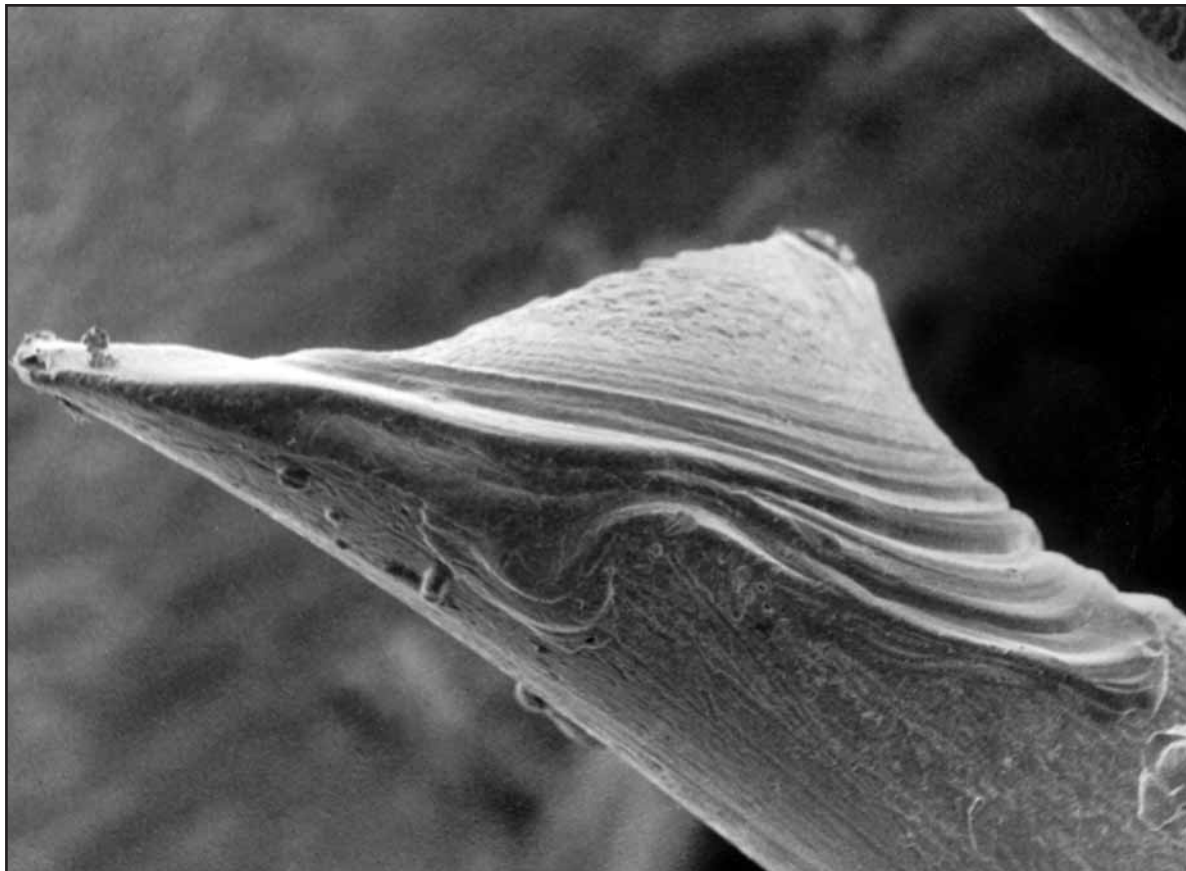
Fig. 70: A lightning strike has subjected this wire to considerable local heat causing the steel to melt.

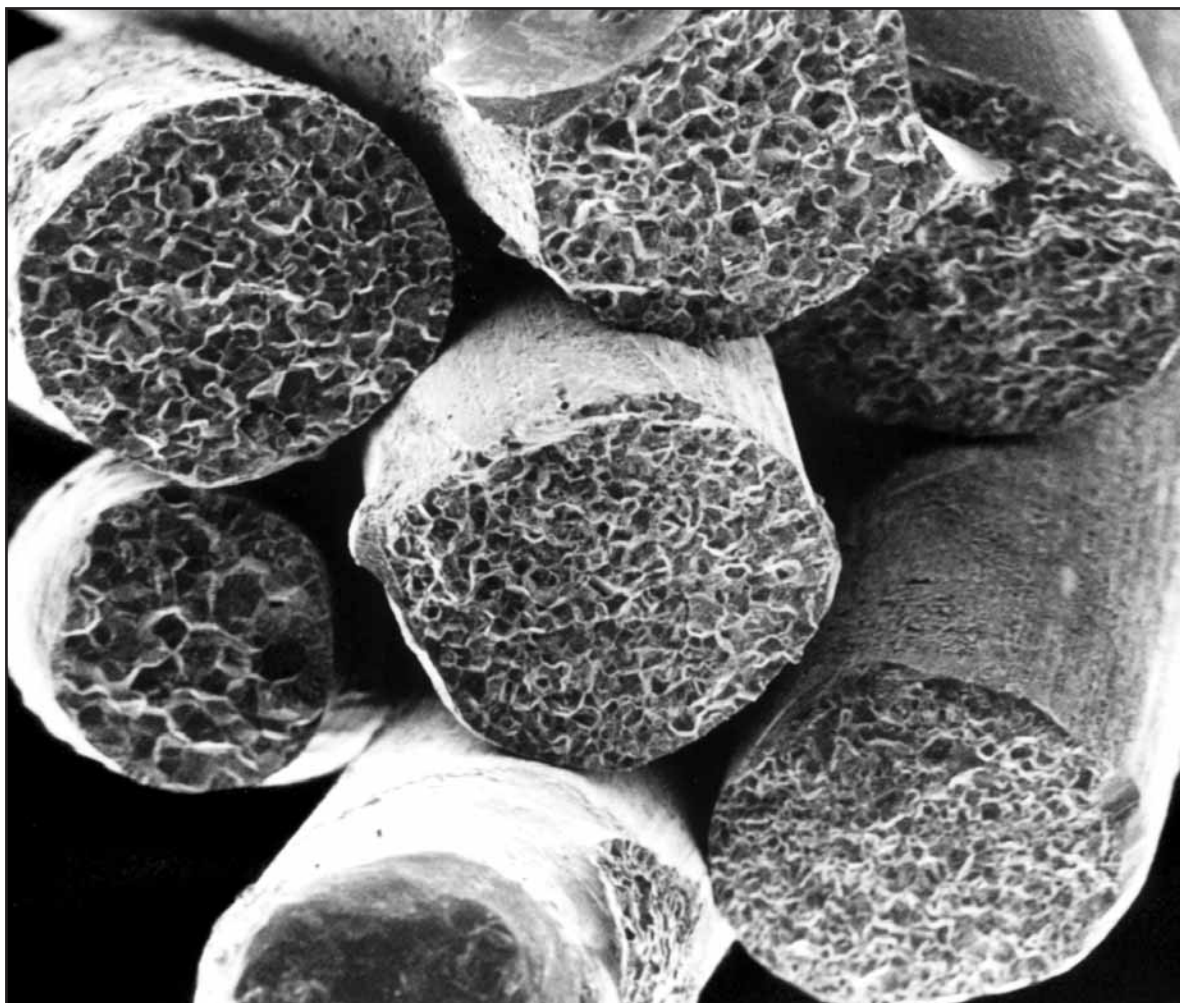
Fig. 71: This seven wire strand has been subject to temperatures greater than approximately 300°C. The microstructure of the wires has undergone a recrystallization from the highly oriented drawn wire structure.

If, however, the temperature within the rope wires exceeds approximately 300°C, the microstructure of the cold drawn wires will recrystallize (Figs. 71, 76 and 77), losing about two-thirds of the wire tensile strength in the process.

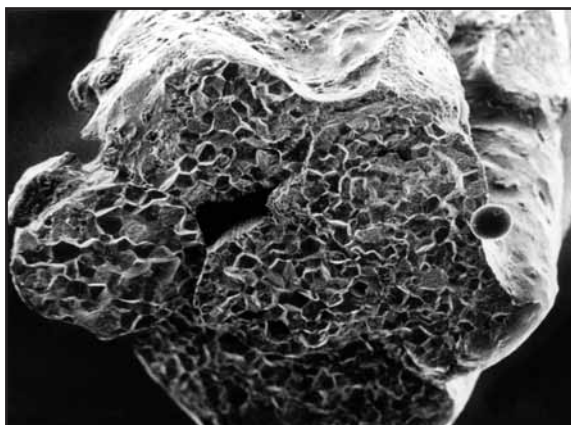
Fig. 72: At even higher temperatures, the steel will melt and the individual wires fuse.

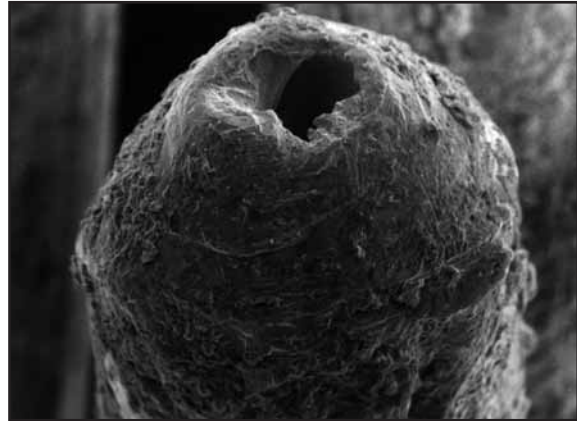
Fig. 75: Detail of wire shown in the top right of Fig. 74. Here, the temperature was even high enough to melt the wire.

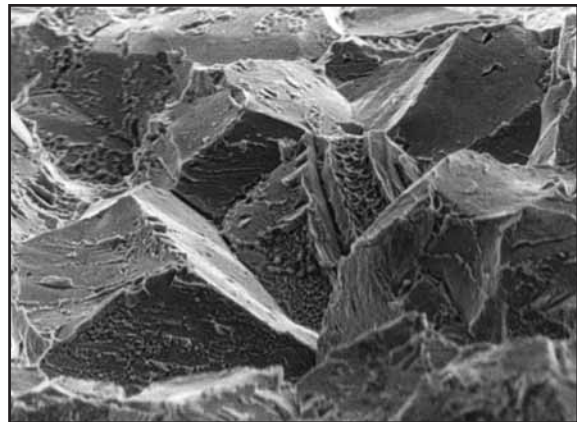
Fig. 77: This detail of Fig. 76 shows the intergranular fracture of the crystalline structure.

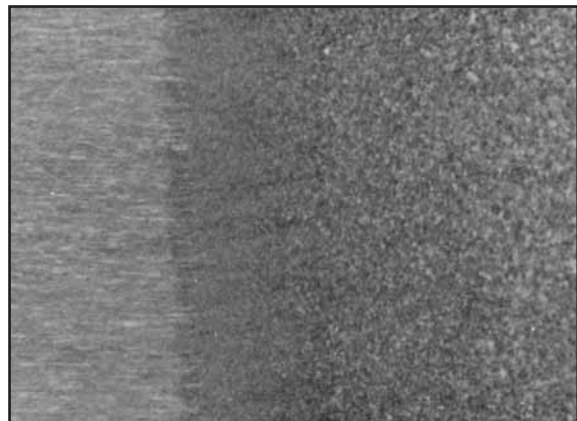
Fig. 79: This etched sample shows the transition from the cold drawn wire structure (left) to the recrystallized structure (right).
