# CASAR<sup>®</sup>

## Wire Rope Forensics

by Dipl.- Ing. Roland Verreet and Dr. Isabel Ridge

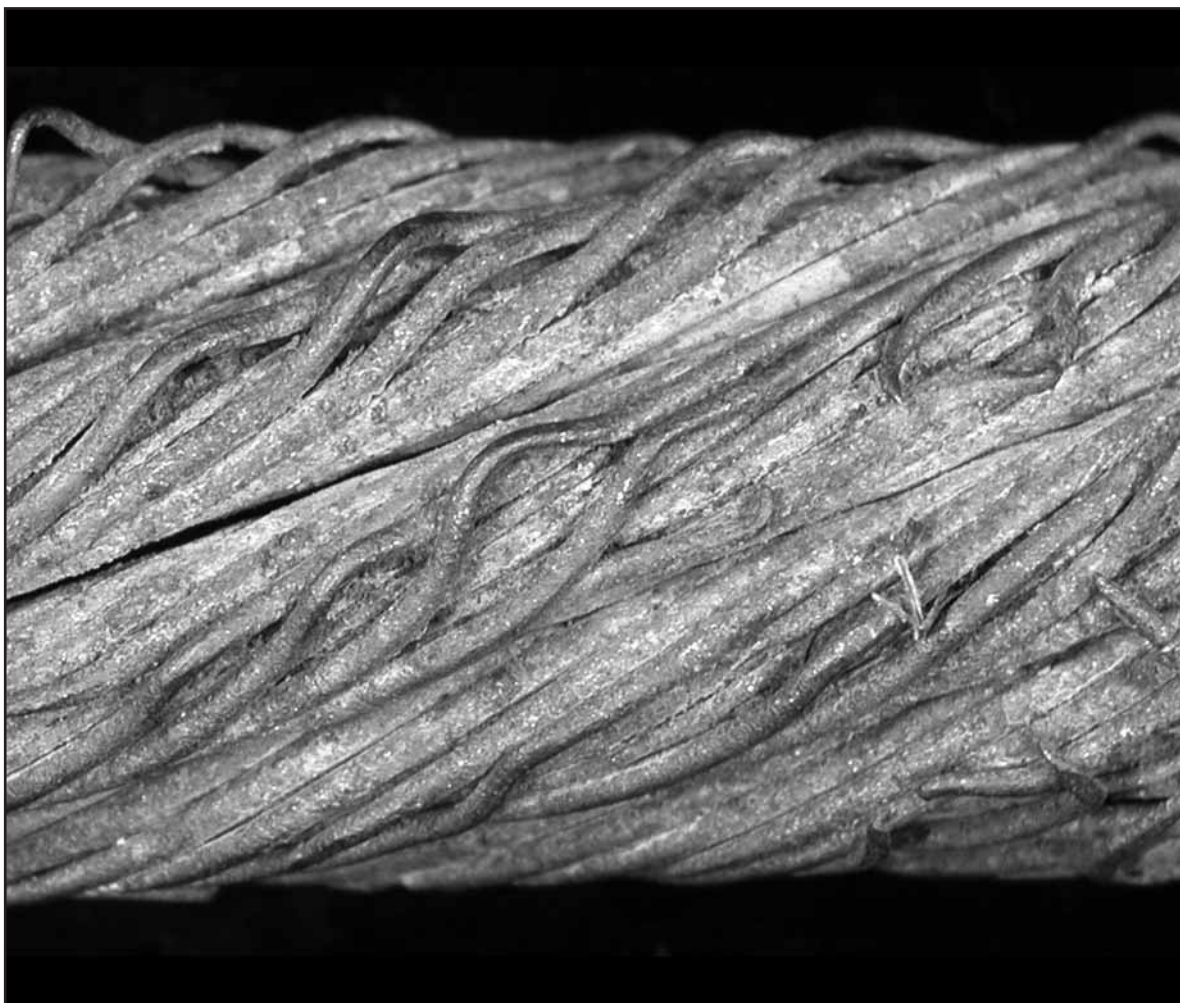
Fig. 80: This hoist rope from a ladle crane has been exposed to elevated temperatures for too long. As a result of this the outer wires have annealed, softened and then lengthened in service.

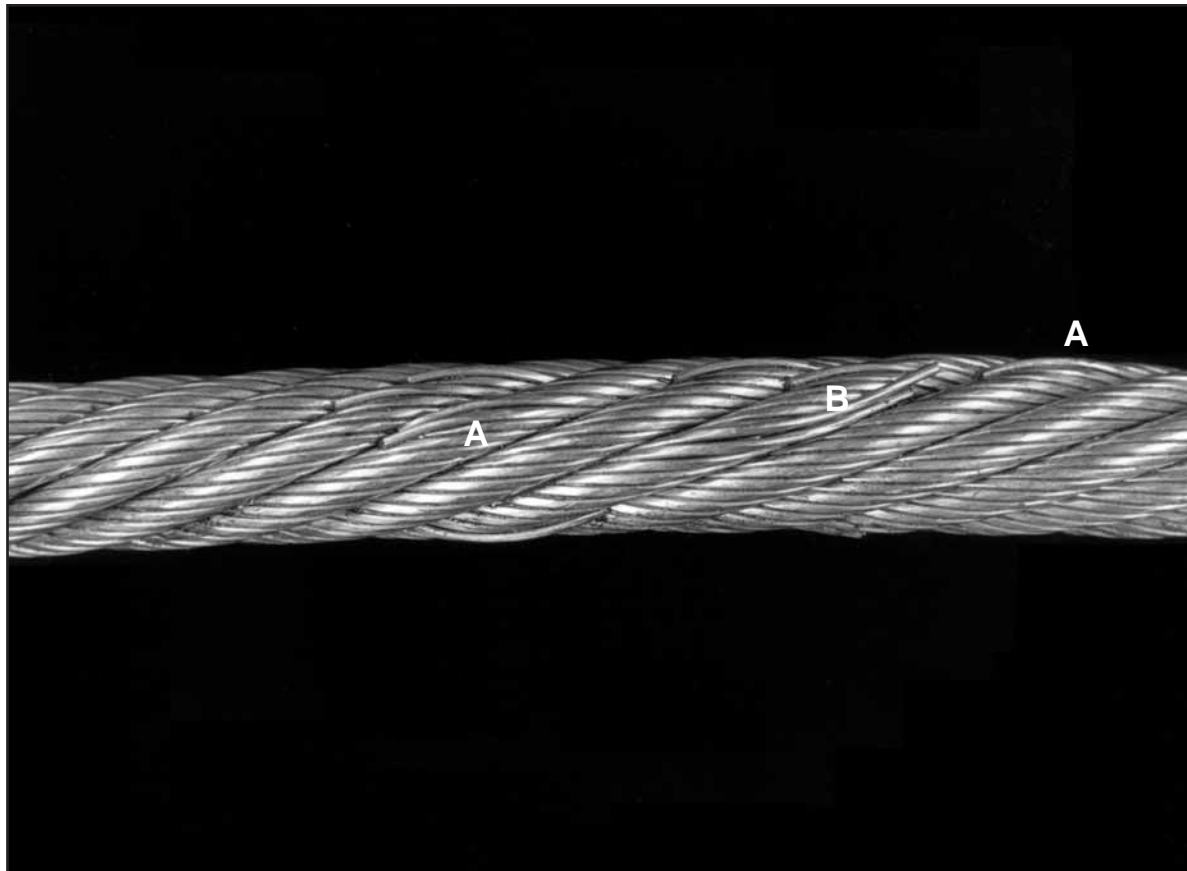
Fig. 83: An eight strand rope showing evidence of internal wire breaks. Please note that the broken wire ends are twice as long (A, broken in the valley) or three times as long (B, broken underneath the outer strand) as they would be had they broken at the crown.

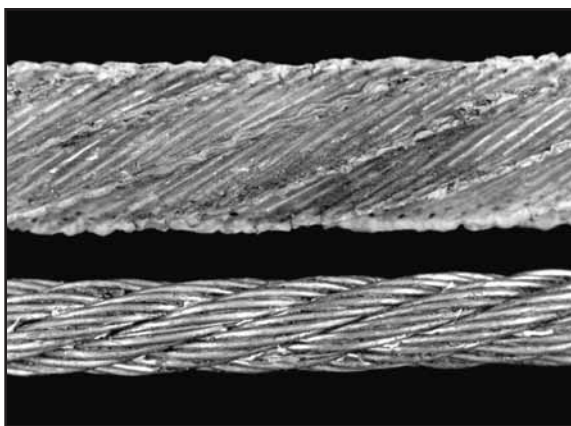
Fig. 86: Undamaged plastic coated steel core of a discarded rope after removing the outer strands and after removing the plastic layer.

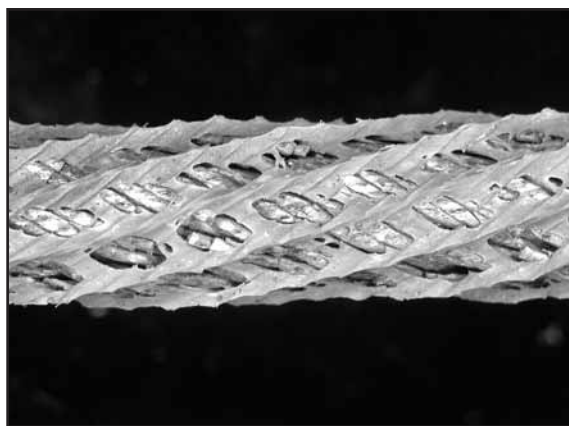
Fig. 87: Damaged plastic layer perforated by the outer and inner strands. The hardness of the plastic was insufficient for the purpose.

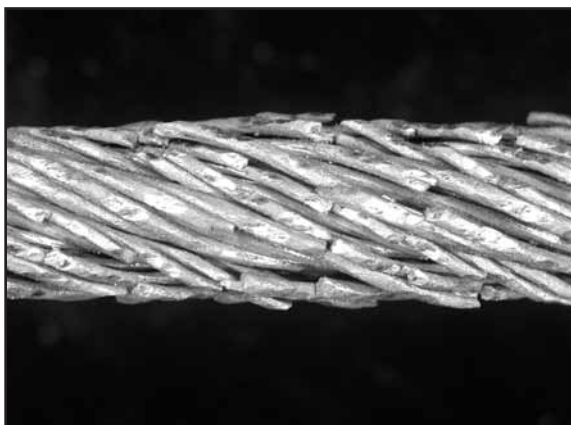
Fig. 88: The rope core shown in Fig. 87 after removing the plastic layer. The outer wires have broken at the crossover points.

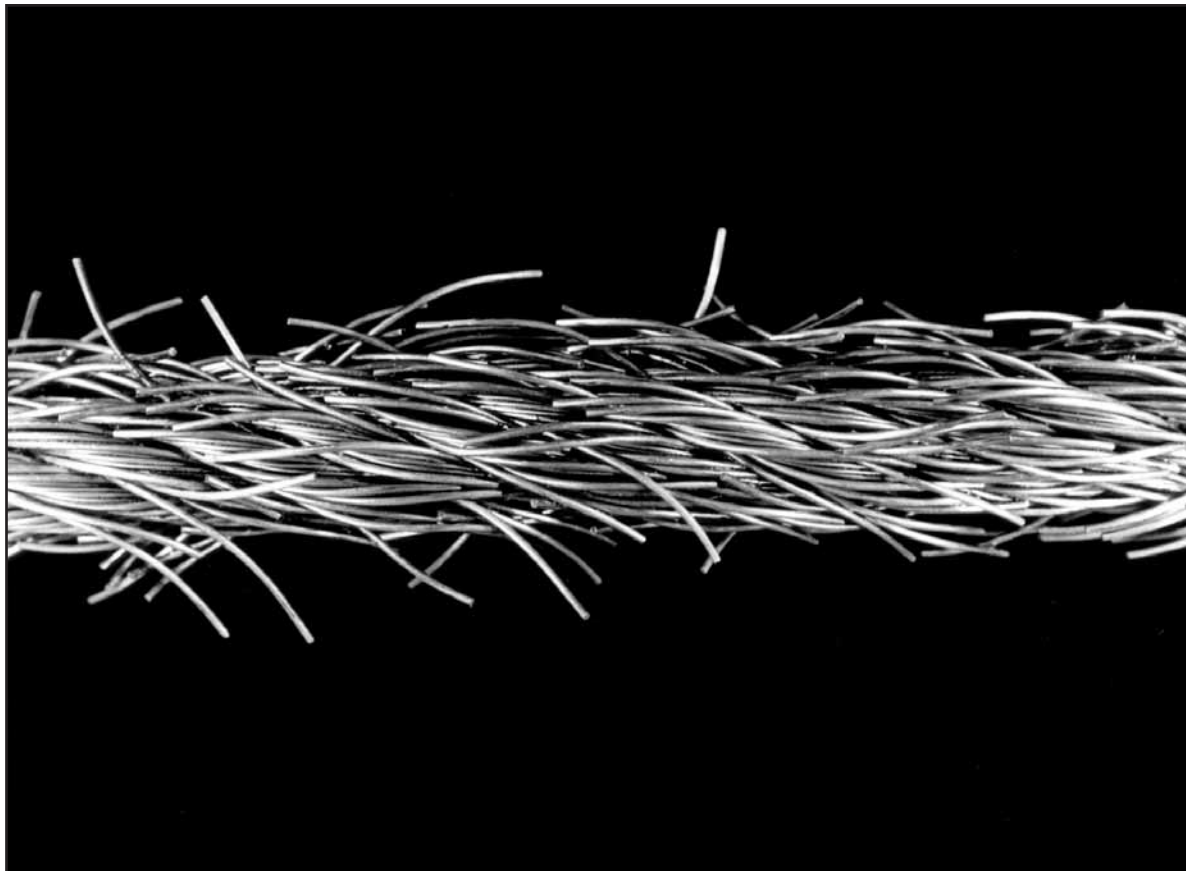
Fig. 90: This rope did not show a single external wire break. Fortunately the inspector severely bent the rope: an incredible number of internal wire breaks became apparent. A plastic layer will help prevent internal wire breaks.

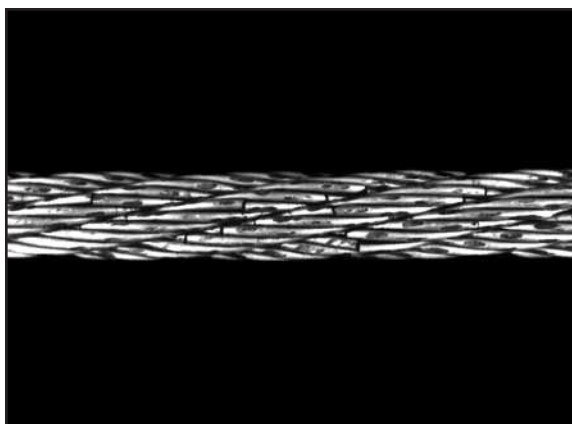
Fig. 93: The innermost strand layer of the same 36 x 7 rope also shows a great number of wire breaks.

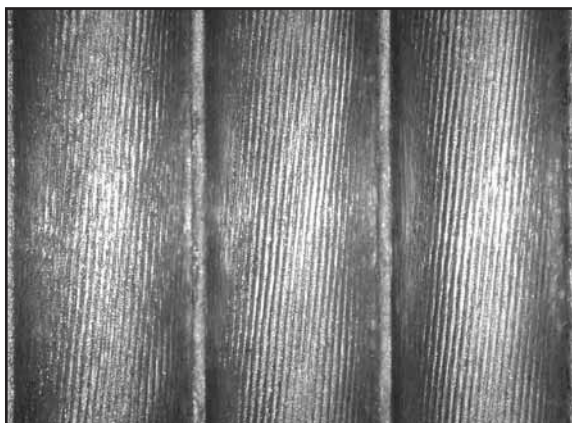
Fig. 95: Longitudinal scratch marks on a drum suggest that the rope might develop internal wire breaks.

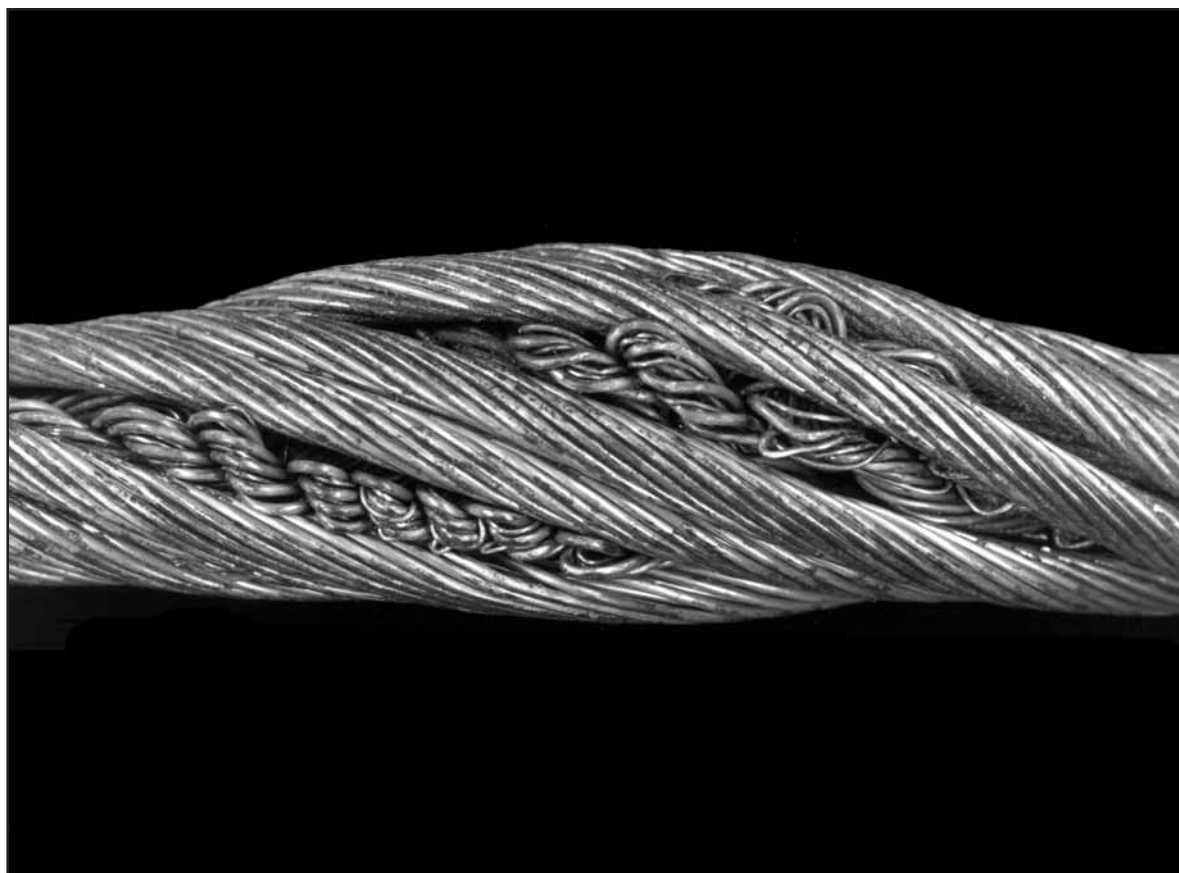
Fig. 97: A surplus of strand lengths in the steel core caused by twisting the rope has been accumulated at one point by a sheave. Defects like this are usually found at the end of the motion of the sheave over the rope (or of the rope over the sheave).

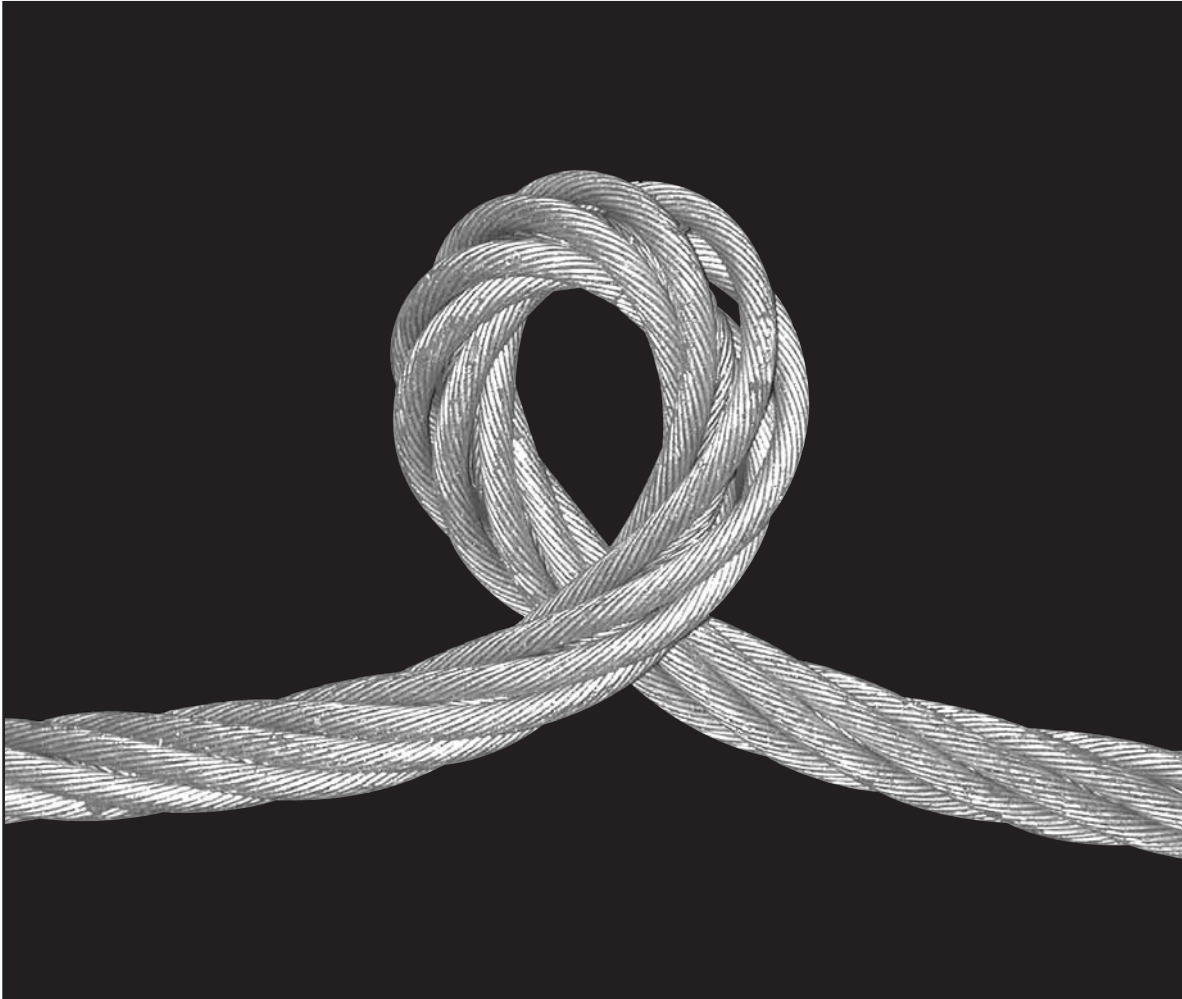
Fig. 104: This rope has been twisted in the opening sense. When slack, it will form a hockle in the closing sense. When hockles are loaded, they might pull tight and permanently deform the rope.

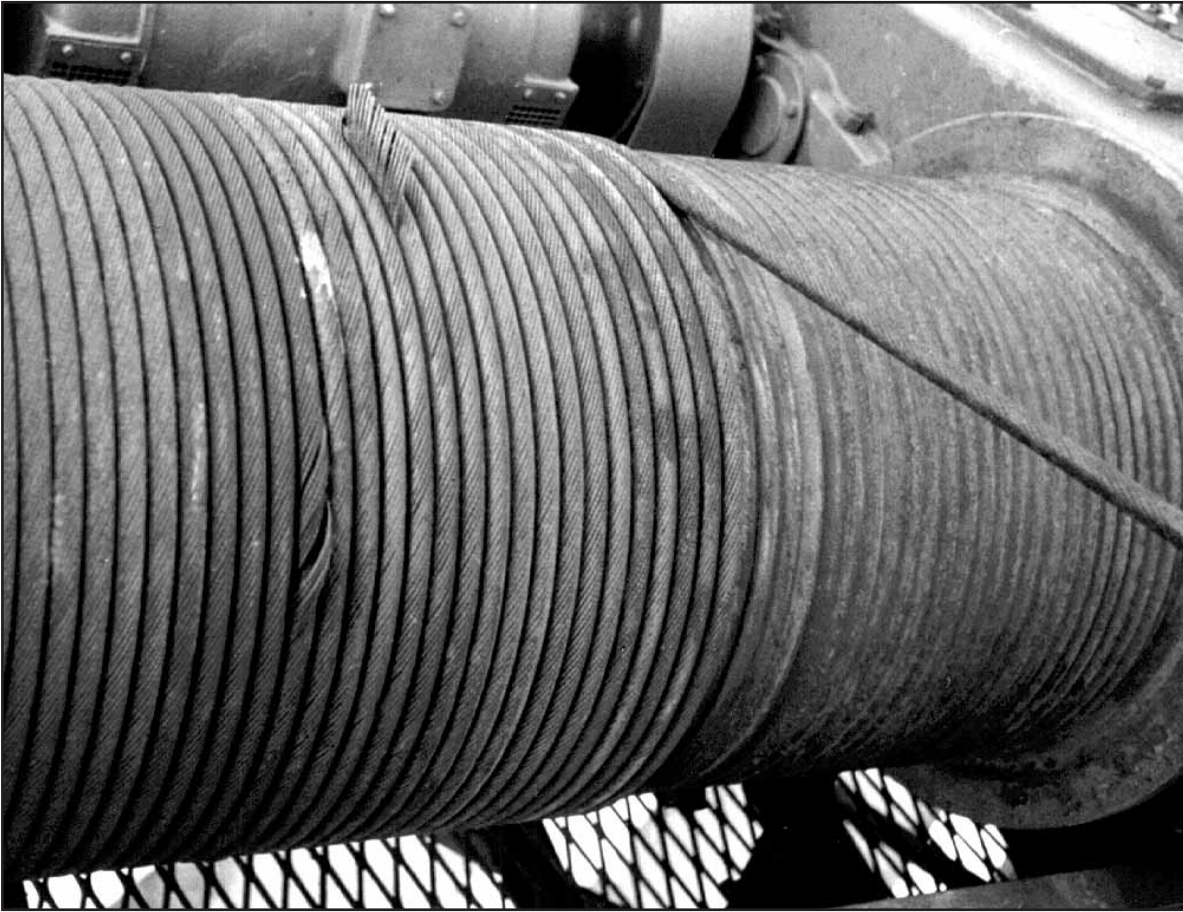
Fig. 108: This semi rotation resistant rope has been attached to a free spinning swivel. Under load, the rope opened up, and twisted rope sections travelled through the reeving system. The sheaves moved the “superfluous” strand lengths through the reeving system until they ended up on the drum. This is a typical example of how an action at one end of the rope (the use of swivel) causes a reaction (the creation of birdcages) at the other.

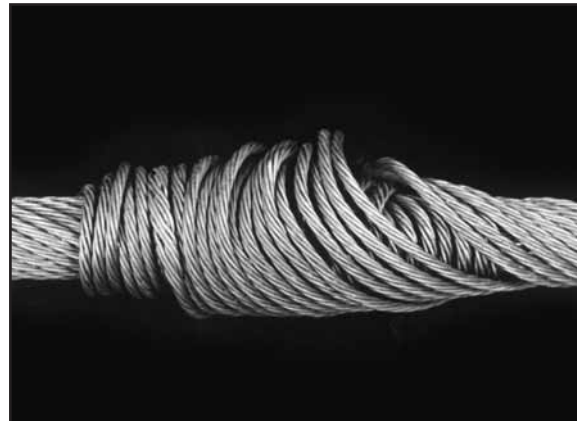
Fig. 110: Another example of a birdcage on a rotation resistant rope.

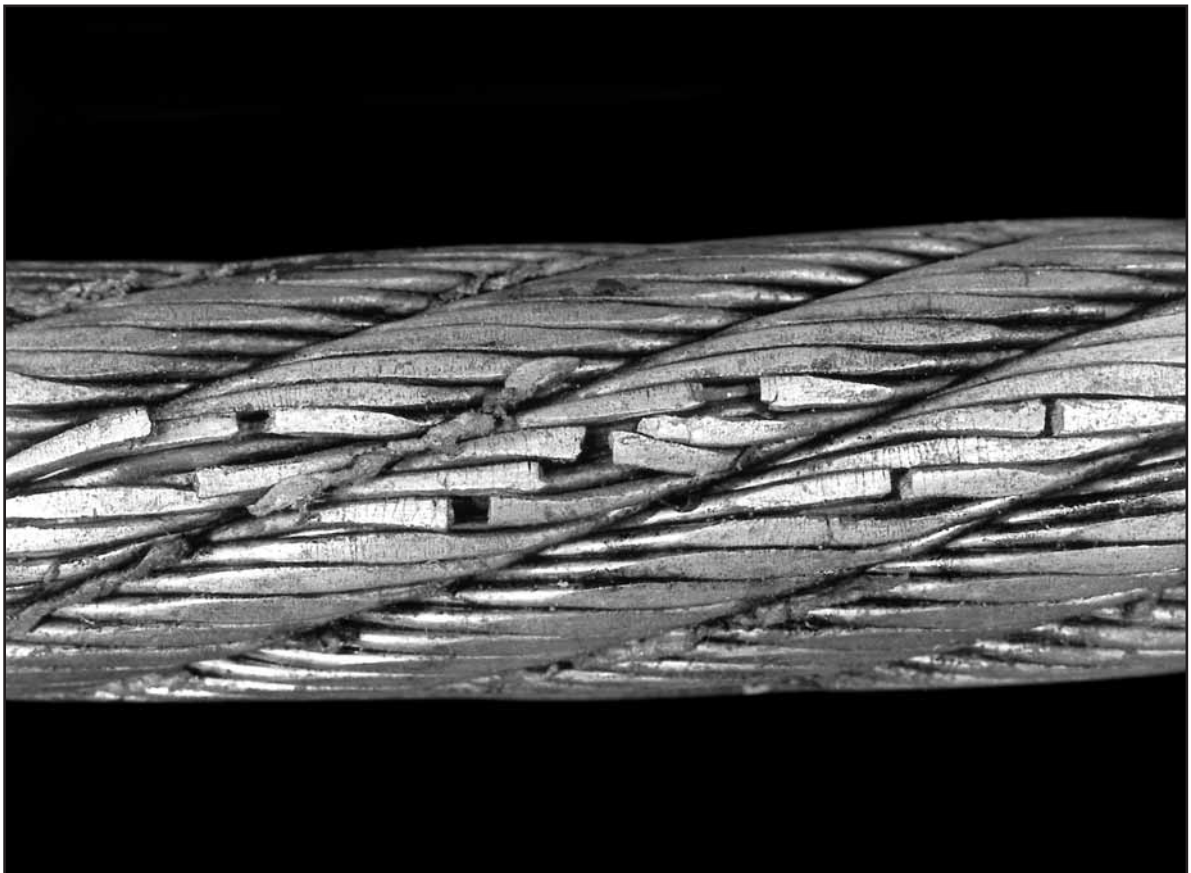
Fig. 111: This eight strand rope has worked in a tight sheave. Its internal plastic layer has prevented the formation of a birdcage, but a lot of cracks have formed in the galvanized outer wires (see also Figs. 68 and 69 from the same rope).

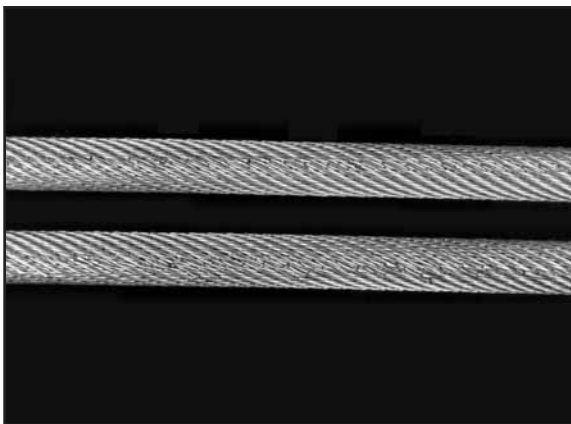
Fig. 114: This rope has operated in a groove which was much too wide, leading to premature wire failure along the line of contact.

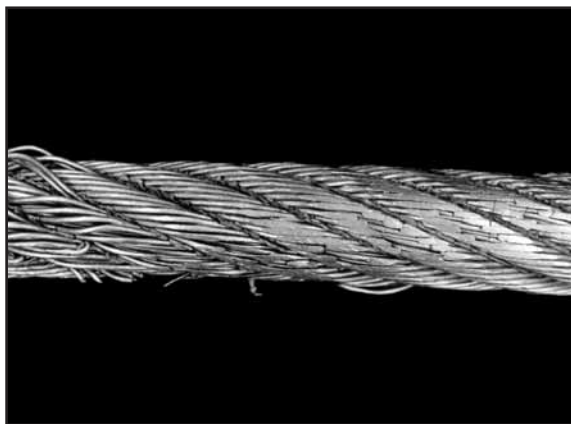
Fig. 115: This rope has been dragged over a stuck sheave. Note severe abrasion to the right and loose wires to the left.

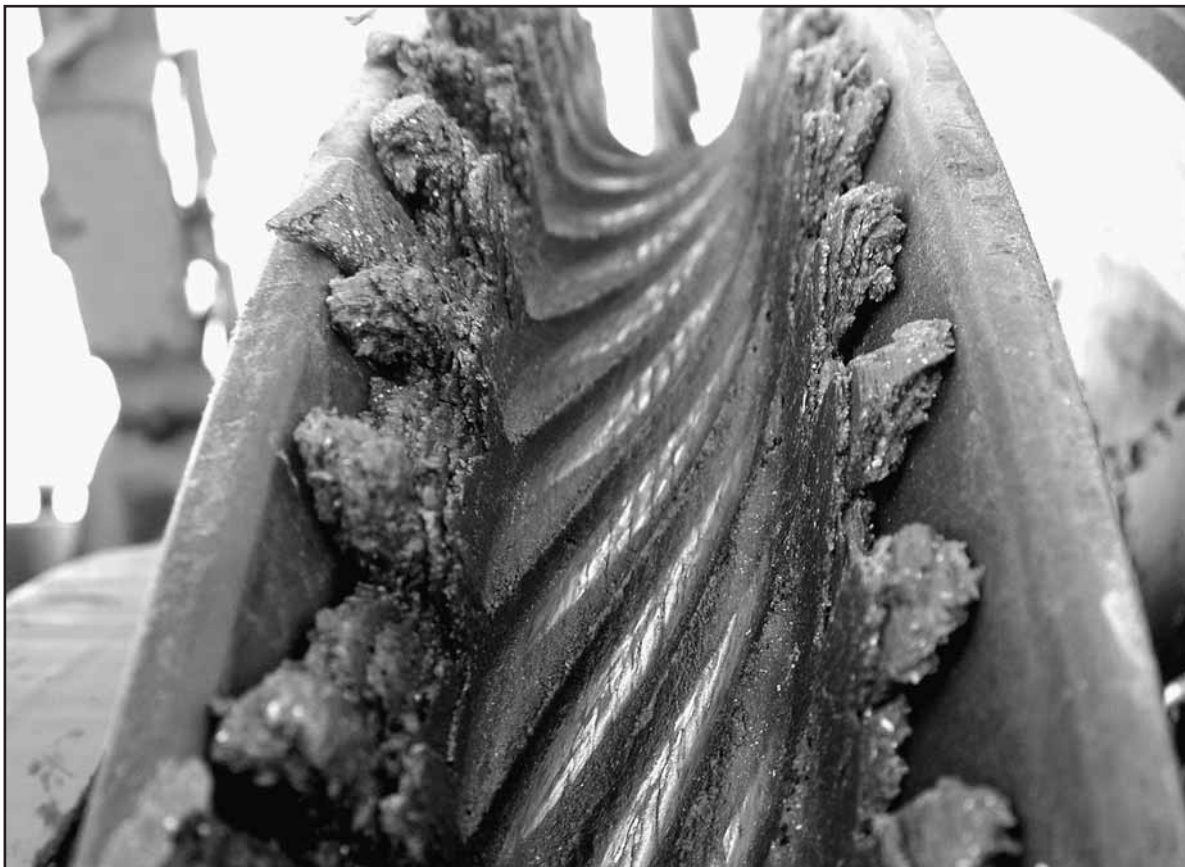
Fig. 118: Lubricant deposition at regular intervals on the flanges of a sheave as opposed to a continuous coating often indicate the formation of negative imprints.

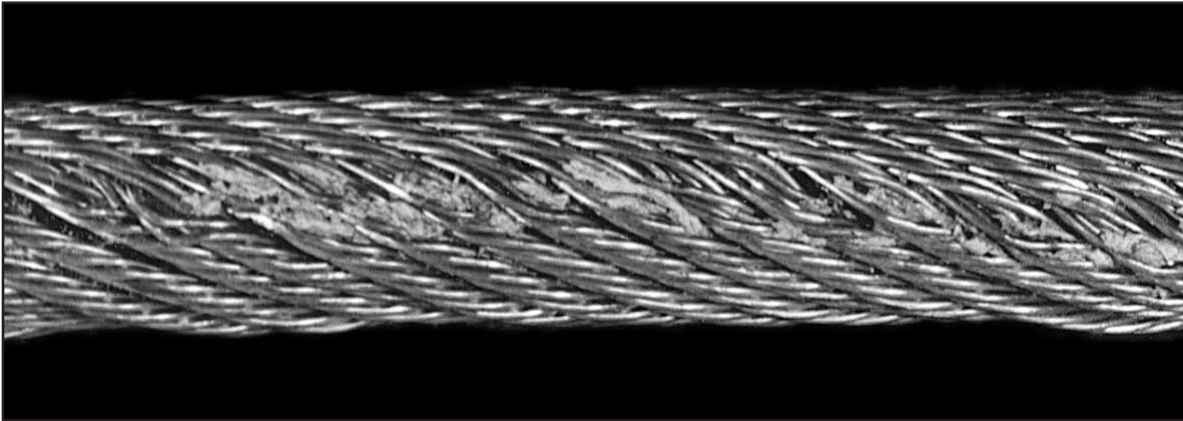
Fig. 119: This rope has “jumped” a plastic sheave. Please note the plastic particles in between the outer wires. Due to the higher coefficient of friction, under otherwise similar conditions, a rope will “jump” a plastic sheave earlier than a steel sheave.

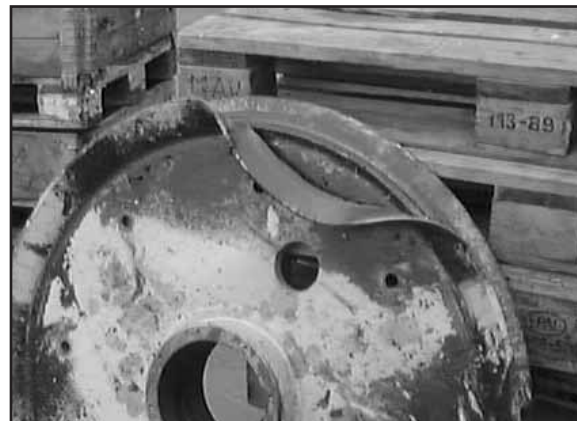
Fig. 123: Extreme wear on the flange will one day cause it to collapse. During inspection, the material thickness must be measured.

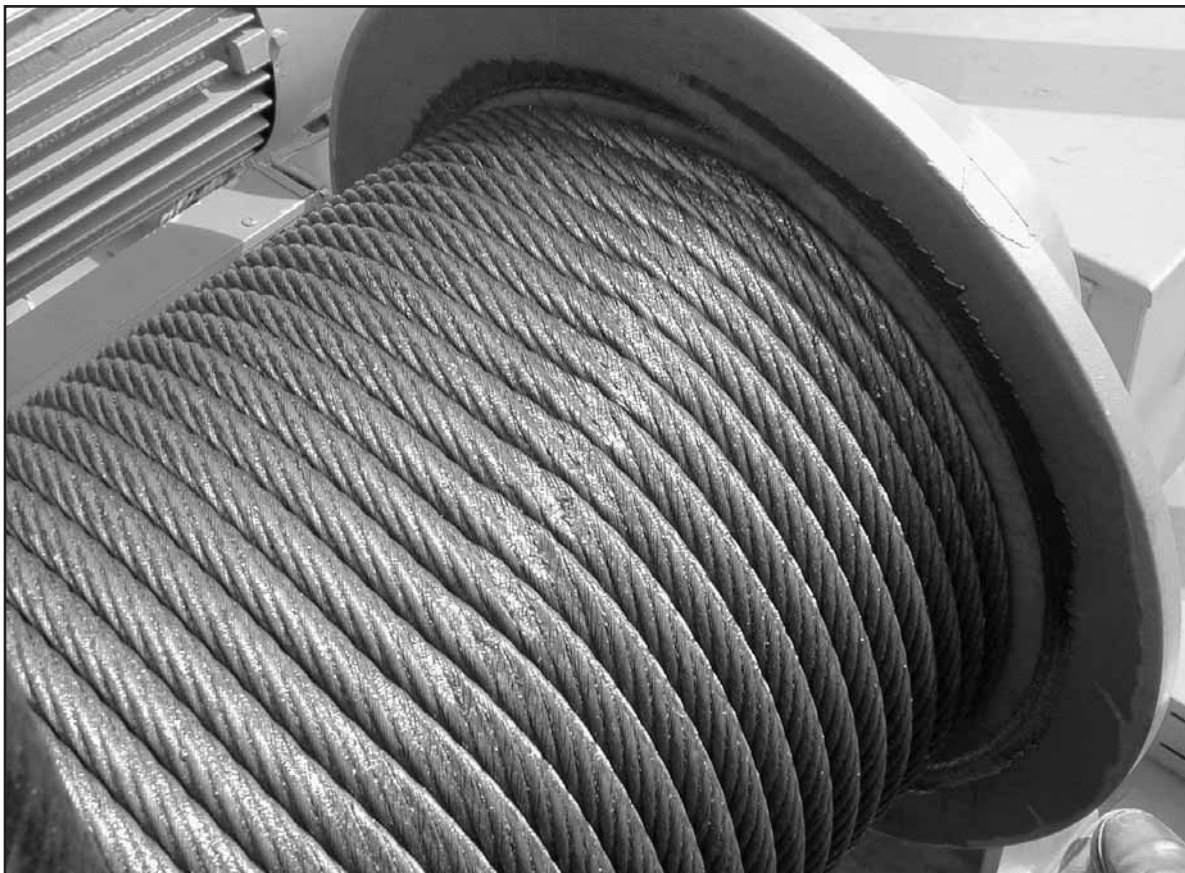
Fig. 124: The inclined wear pattern (cross over zone) shows that the rope is too small for the drum pitch. If it was inclined in the opposite sense, this would be an indication that the rope diameter is too big.

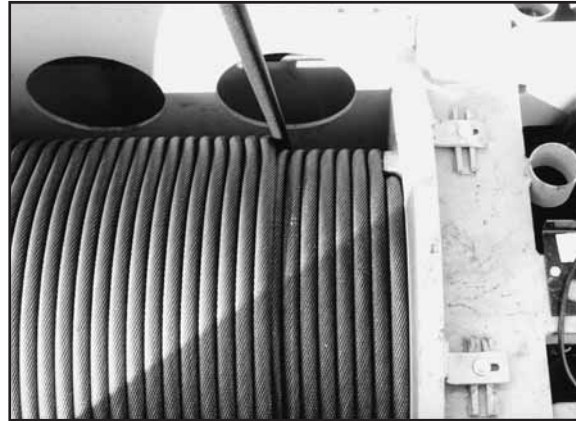
Fig. 126: This rope is spooling onto a multi layer drum with special grooving. The rope is about to cross over one wrap.

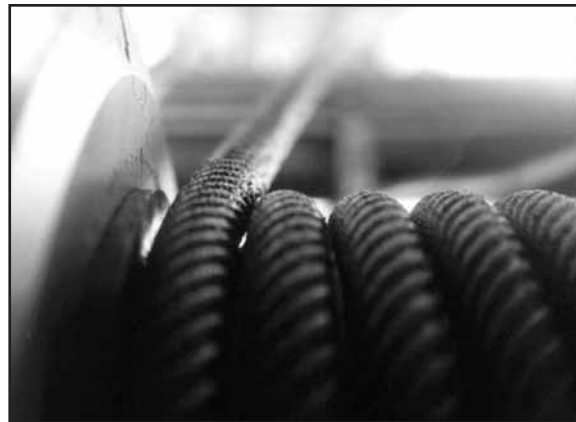
Fig. 128: The fleet angle forces the rope fall entering the drum to rub against its "neighbour", causing severe abrasion and rope twist.

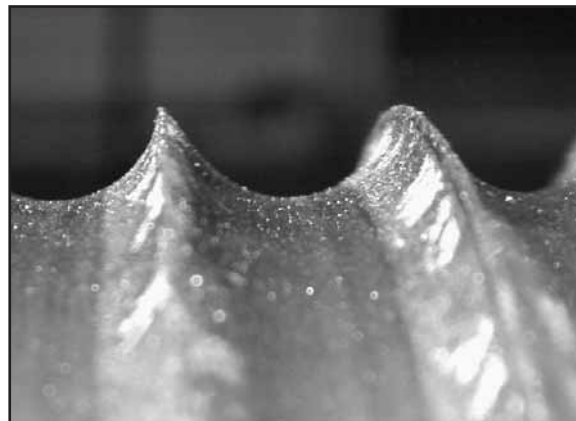
Fig. 130: If a fleet angle forces the rope fall entering the drum to rub against the groove flanges, both rope and flange might be worn.

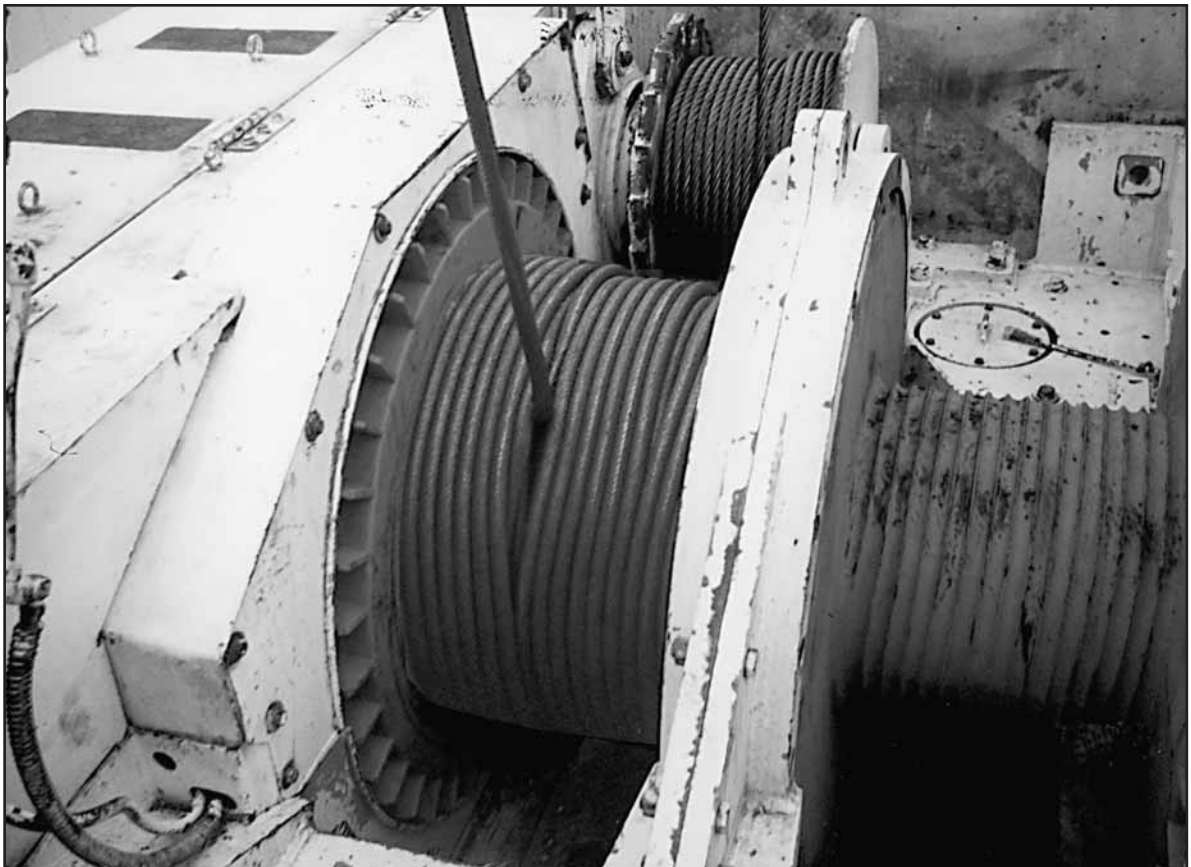
Fig. 131: This rope has been pulled into a lower, non tensioned layer during lifting. During subsequent lowering of the load, the rope got stuck and did not spool off the drum, thereby reversing the load movement.

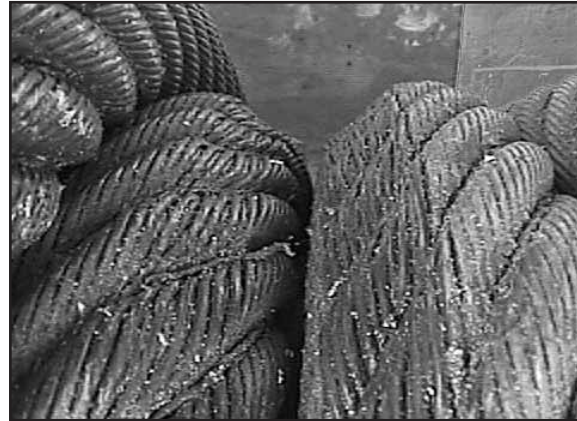
Fig. 133: This rope, too, has only made one lift! Again, lack of pretension caused the rope damage.

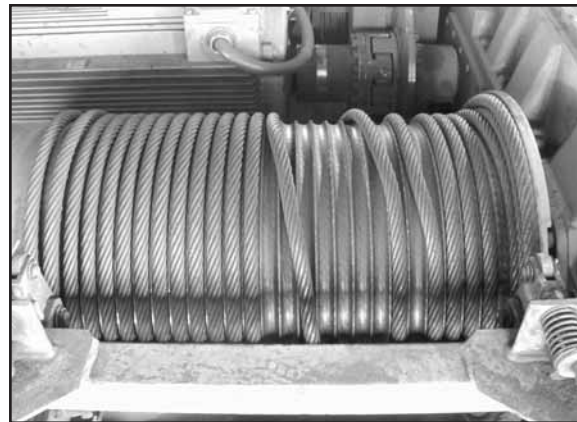
Fig. 135: Steel wire rope and drum damage caused by spooling over the groove flanges.

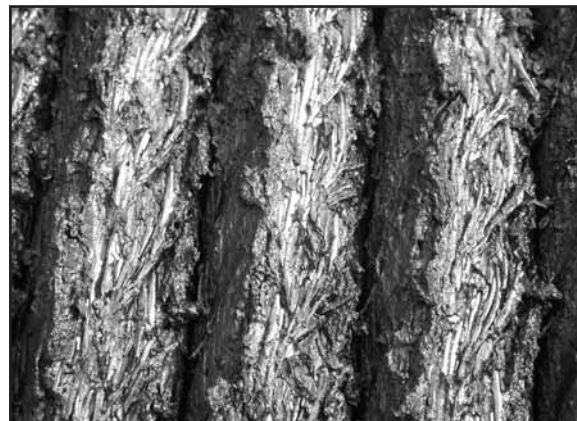
Fig. 137: this rope was ready for discard (see Fig. 136). Further examination showed that every outer wire was broken every 3 cm.

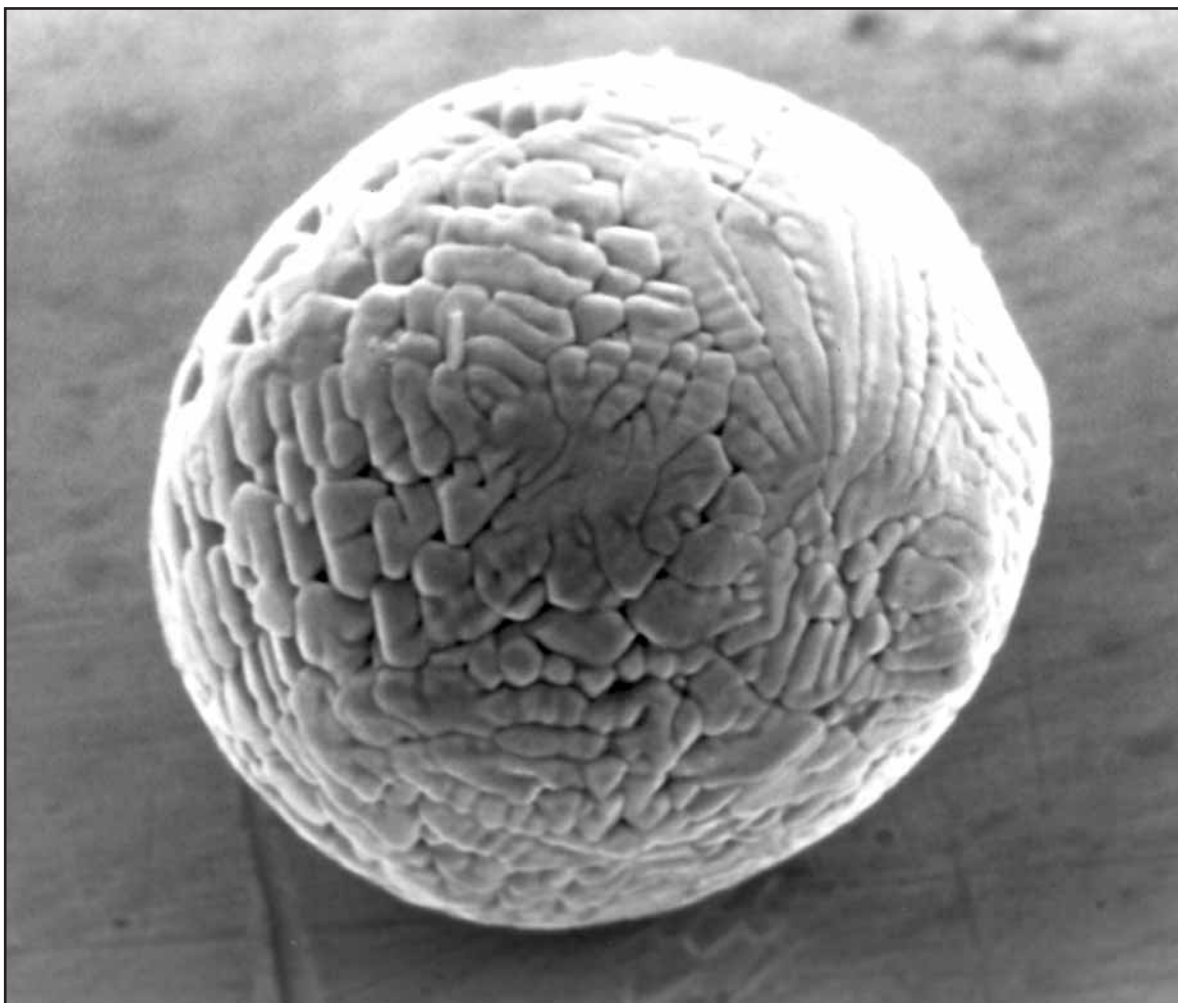
Fig. 138: Manganese- Sulphite balls in the wire structure are extremely hard and do not deform in the wire drawing process. They often appear on the surface of fatigue breaks because wires will tend to fail in sections already weakened by such inclusions.

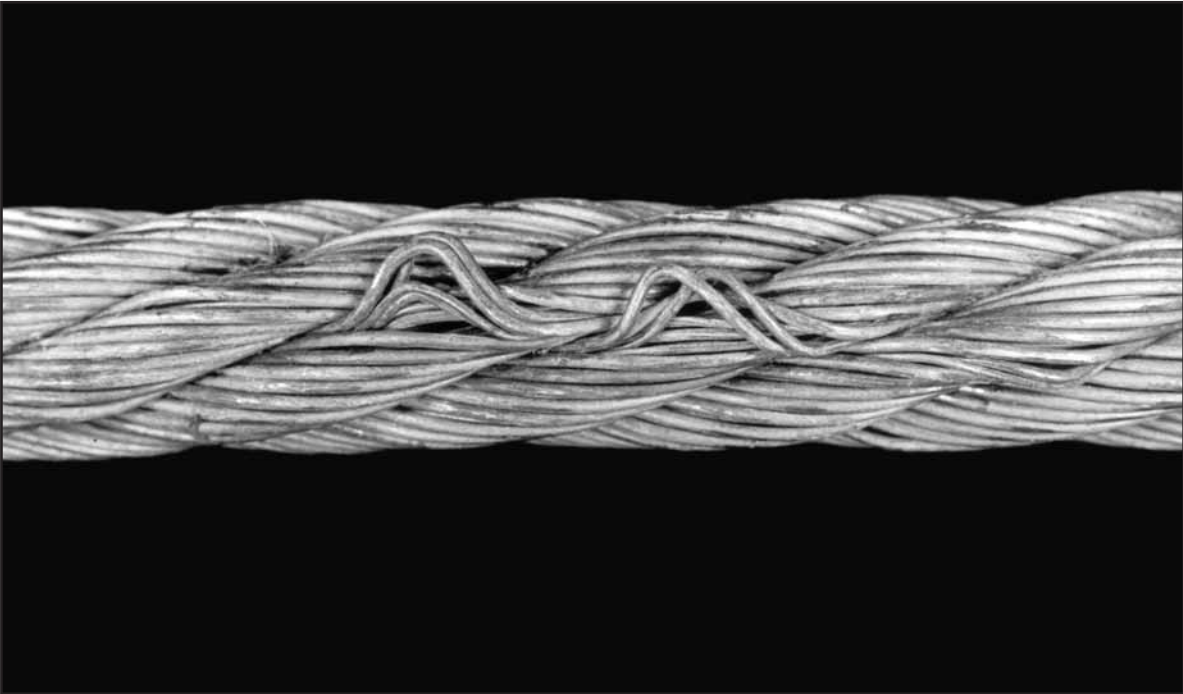
Fig. 141: Loop formations can be (but may not be) caused by insufficient clearance between the wires in the strand. Lack of clearance will prevent these wires from moving relative to their neighbours, causing overloading and yield.

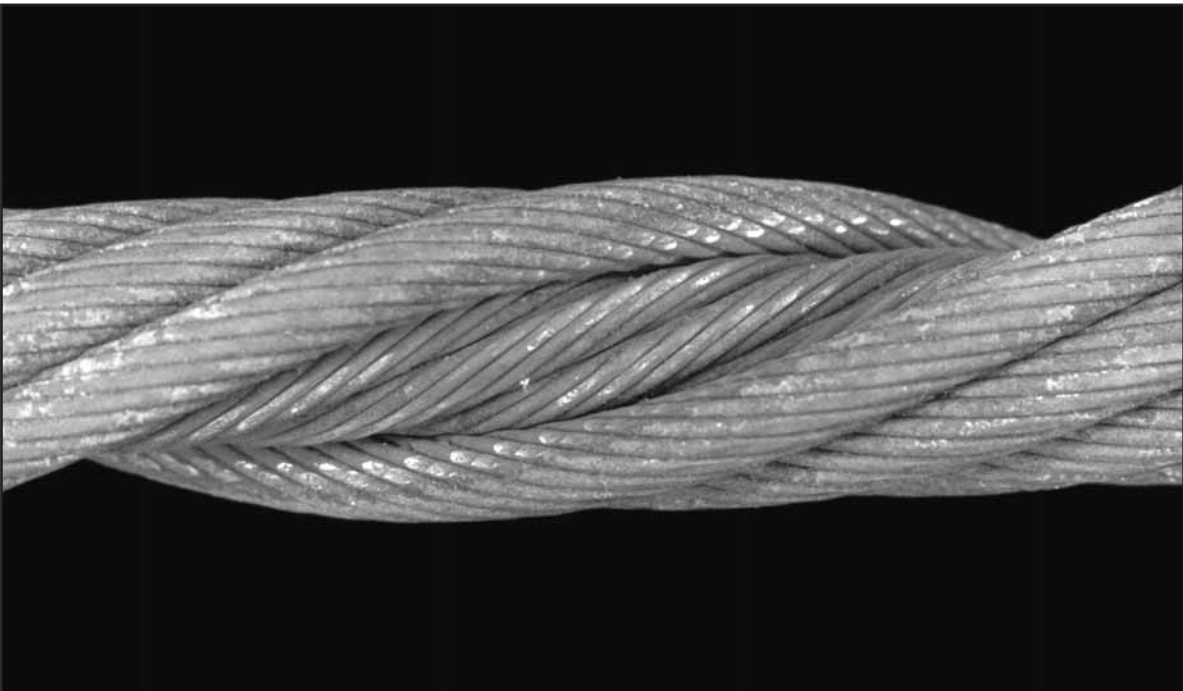
Fig. 142: If the diameter of the steel core of the rope is too small, the outer strands will not have sufficient clearance. Interstrand nicking will occur. Lack of clearance will considerably reduce the rope's fatigue life.

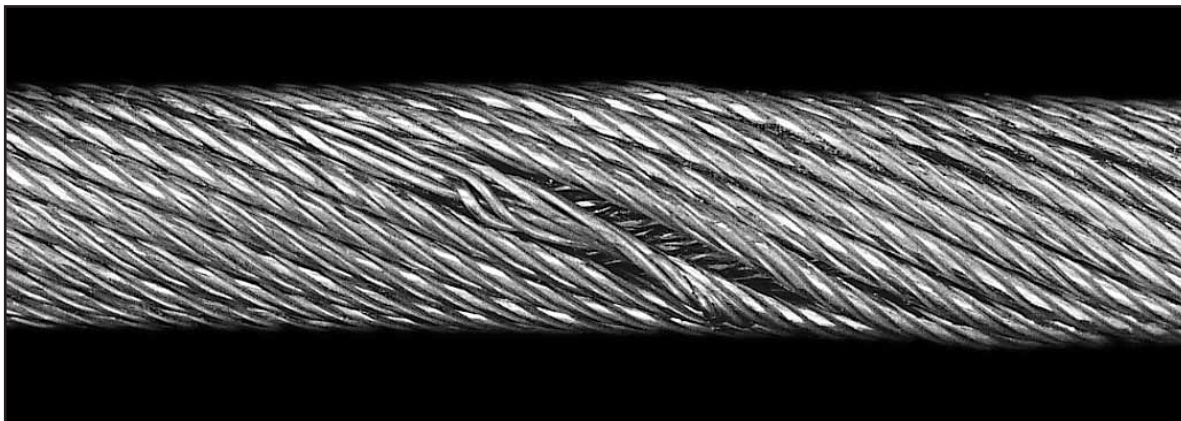
Fig. 143: During stranding, one strand obviously had slipped on the capstan, locally creating a long lay length. This stranding defect was not detected before the faulty strand was closed into the rope.

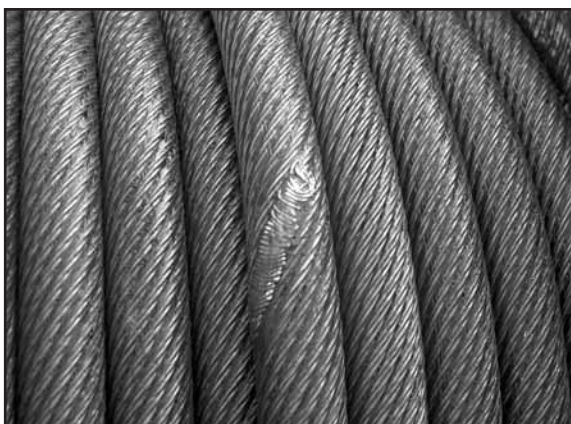
Fig. 144: A strand serving was not removed during rope closing and ended up as an unpleasant decoration of the finished rope.
